4/15/2021

Abalone Cove Landslide Abatement District
P.O. Box 3675
Palos Verdes Peninsula, CA 90274.
Attention: Tim Kelly and Michael Barth

**Second Site Meeting and Review Re: Ground Deformation/Local Damage
Near Intersection of Cinnamon Lane and Clove Tree Place
Abalone Cove Residential Area, Rancho Palos Verdes, California**

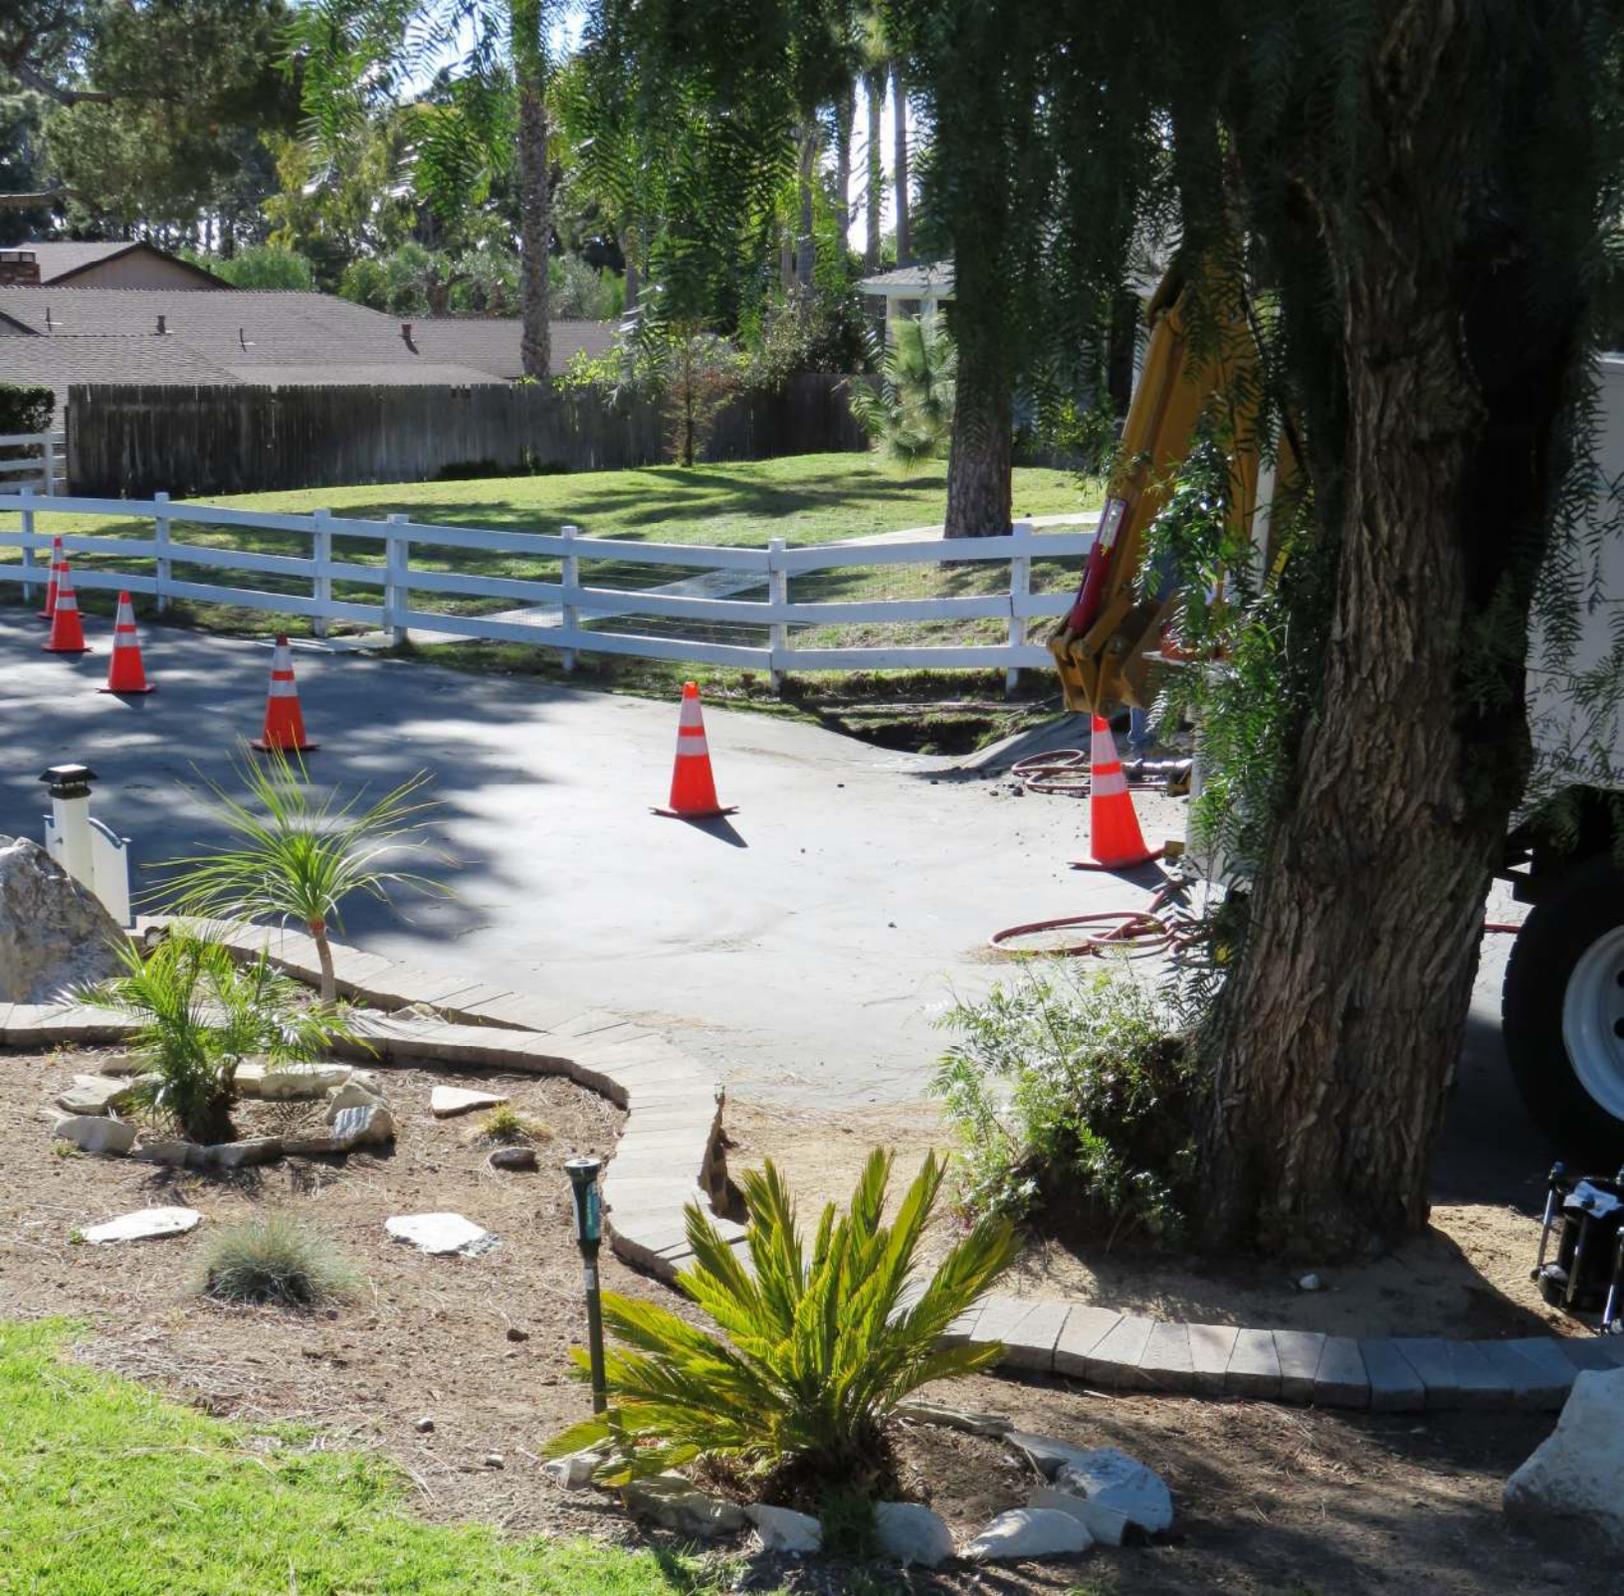
The water main break beneath Clovetree Place was reportedly noticed on the morning of March 19, 2021 and the water to this section of the main was turned off by the fire department. Flow from the break emanated from the edge of the pavement, and although a small local depression was observed in the adjoining pavement at that location, the outflow was reportedly clear, and there was no residual evidence of significant piping erosion of the soil associated with the leak (refer to attached site plan and Photo 1). One of the local residents reported that flow from the broken water main did not appear at the ground surface until about three hours after he lost the water supply at his house. There was no specific information available regarding the timing/occurrence of the various additional distress features in the vicinity, but pavement cracking and ground deformation apparently continued for some time after the water main break was reported. No noticeable increase in the extent or width of the pavement/ground cracks was observed during the site review in the late afternoon and early evening on the day of the water main break (3-19-2021).

Photo 1 - View west from Lot 9 along the trend of the previously observed ground deformation showing the location of the water main break near the westerly edge of the Clovetree Place roadway.

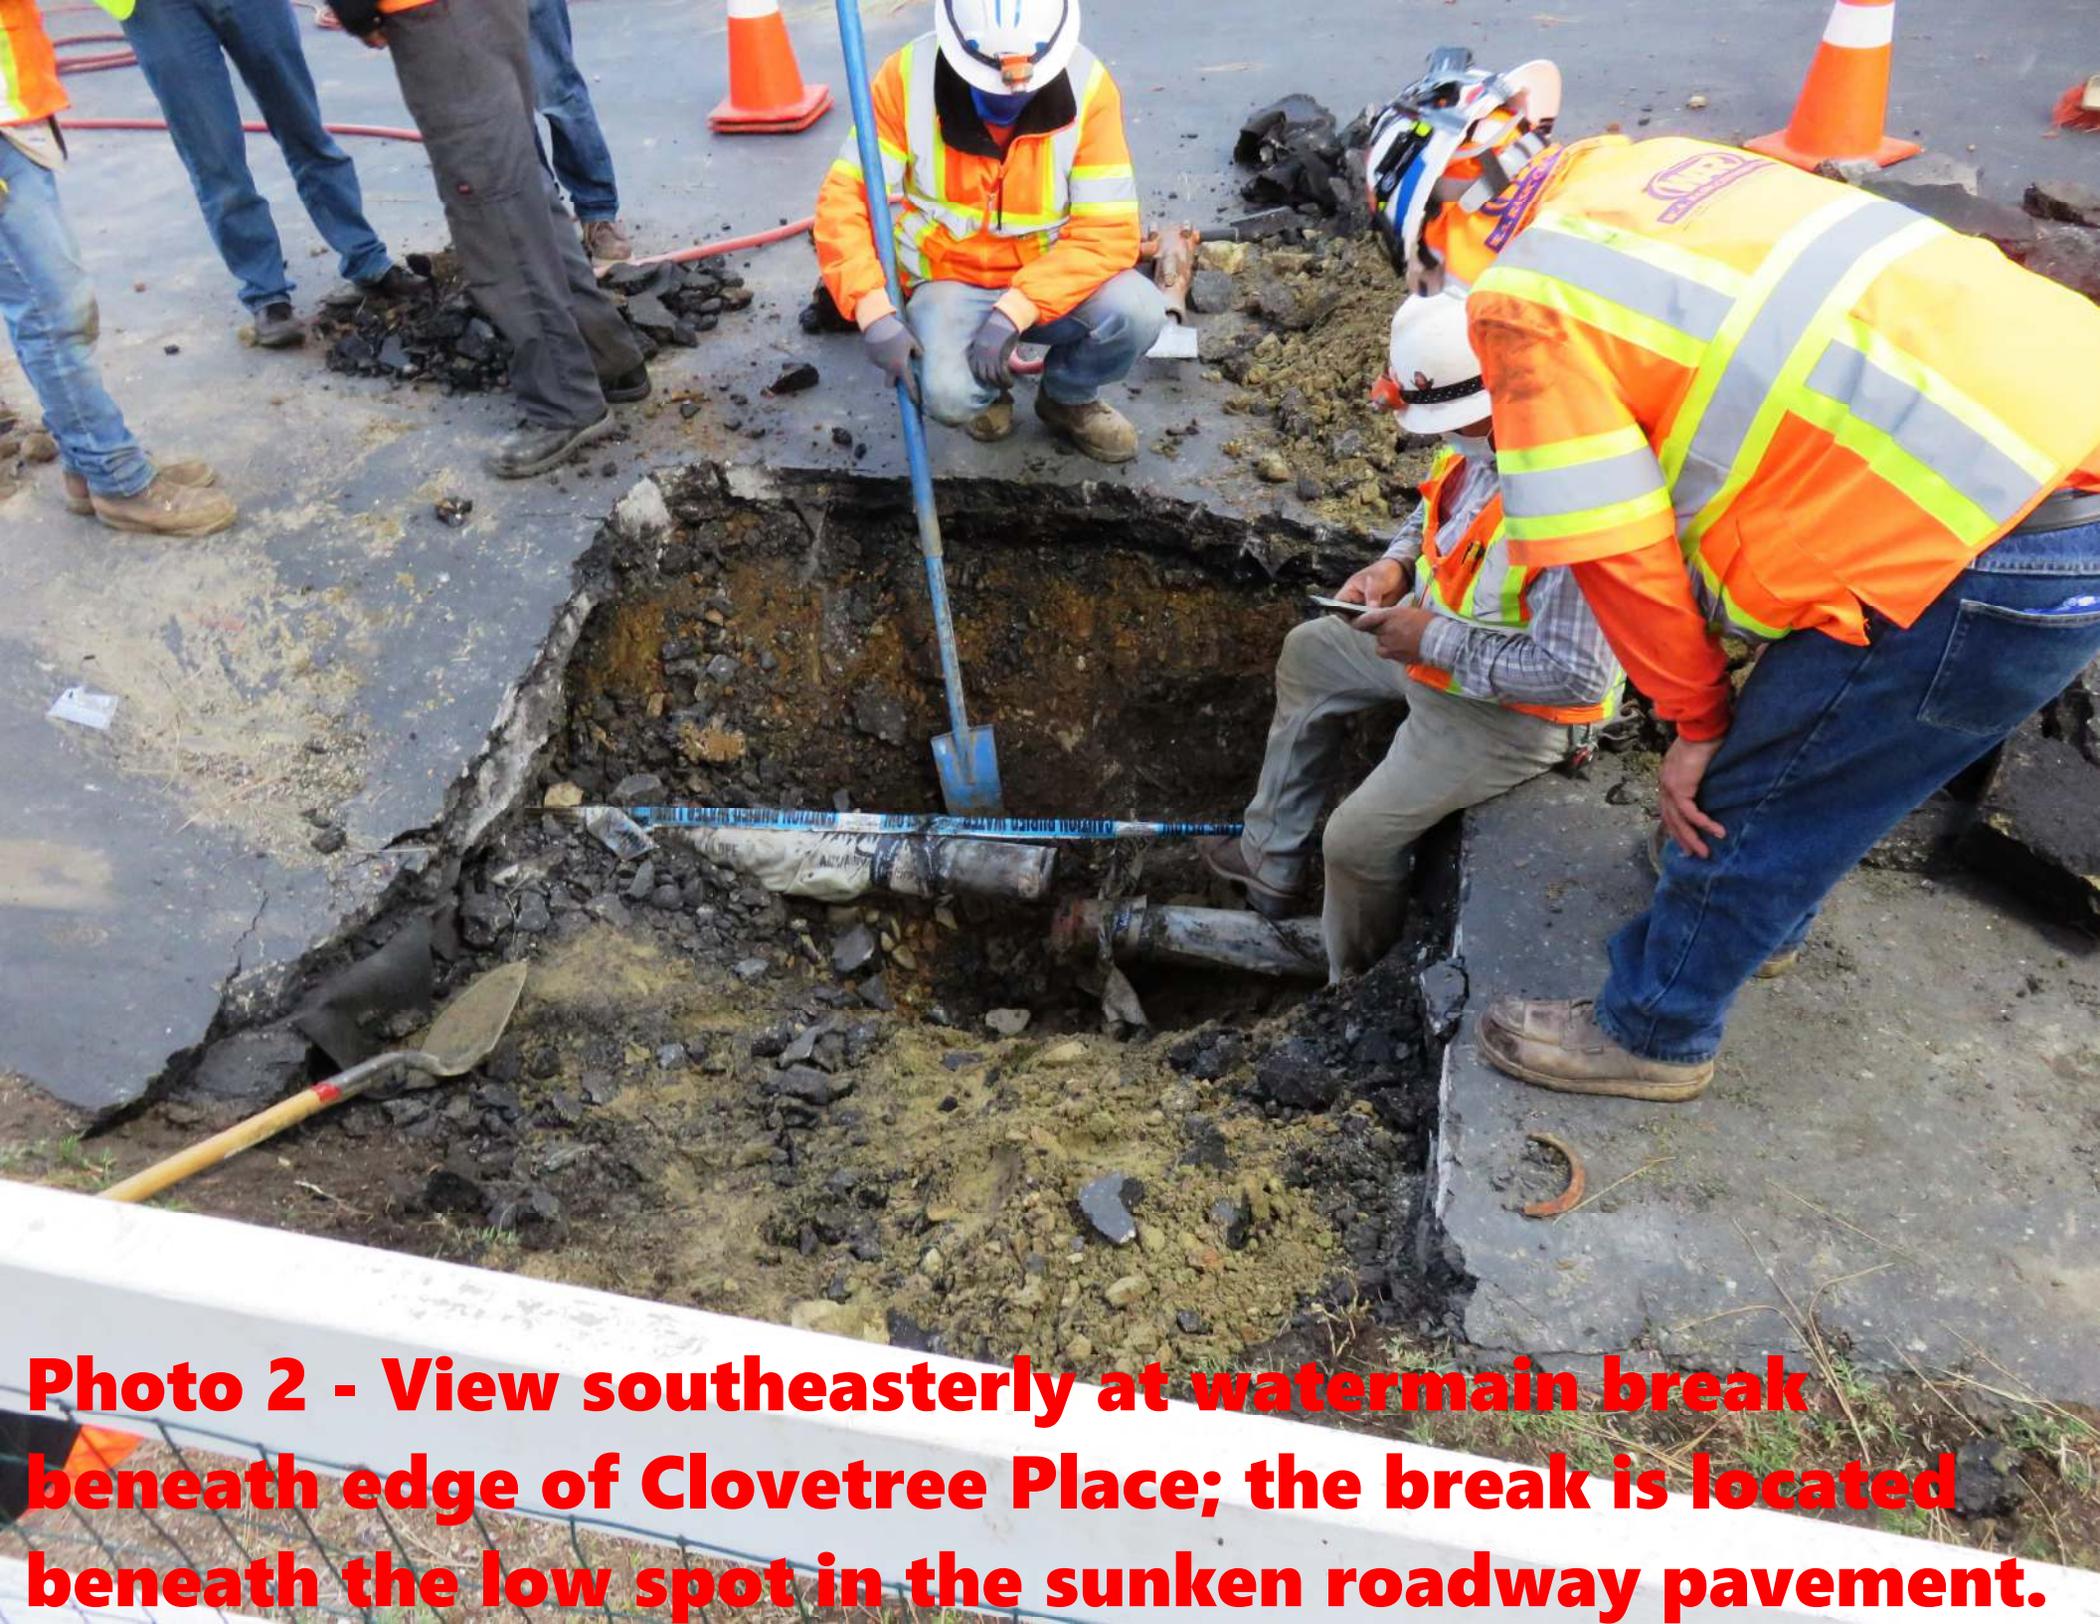
Repair of the water main break and also of the leak in the nearby gas line continued into the evening. The water line pulled apart at a pipe coupling on the south side of the zone of tension cracking, beneath the low point of the pavement deformation (Photos 1 and 2). The water line is shown on the referenced RPVRA sewer design plans as 4-inch diameter, and comparisons using that nominal diameter indicate a local horizontal pipe offset of about 1 to 2 inches, and a vertical offset of about 4 to 5 inches (southerly side down) occurred in the immediate vicinity of the repair excavation (Photo 3). Additional pipe deformation/bending may have occurred immediately north of the excavation, beneath the area of largest vertical pavement deformation (i.e., beneath the landslide scarp). At the time the water line photo was taken (~7:00PM), an ~5 to 6-foot length of the nearby 2-inch diameter gas line had been exposed, but the source of the leak/break had not been located, and no additional observations of the repair process were made.

Photo 2 - View southeasterly at watermain break beneath edge of Clovetree Place; the break is located beneath the low spot in the sunken roadway pavement.

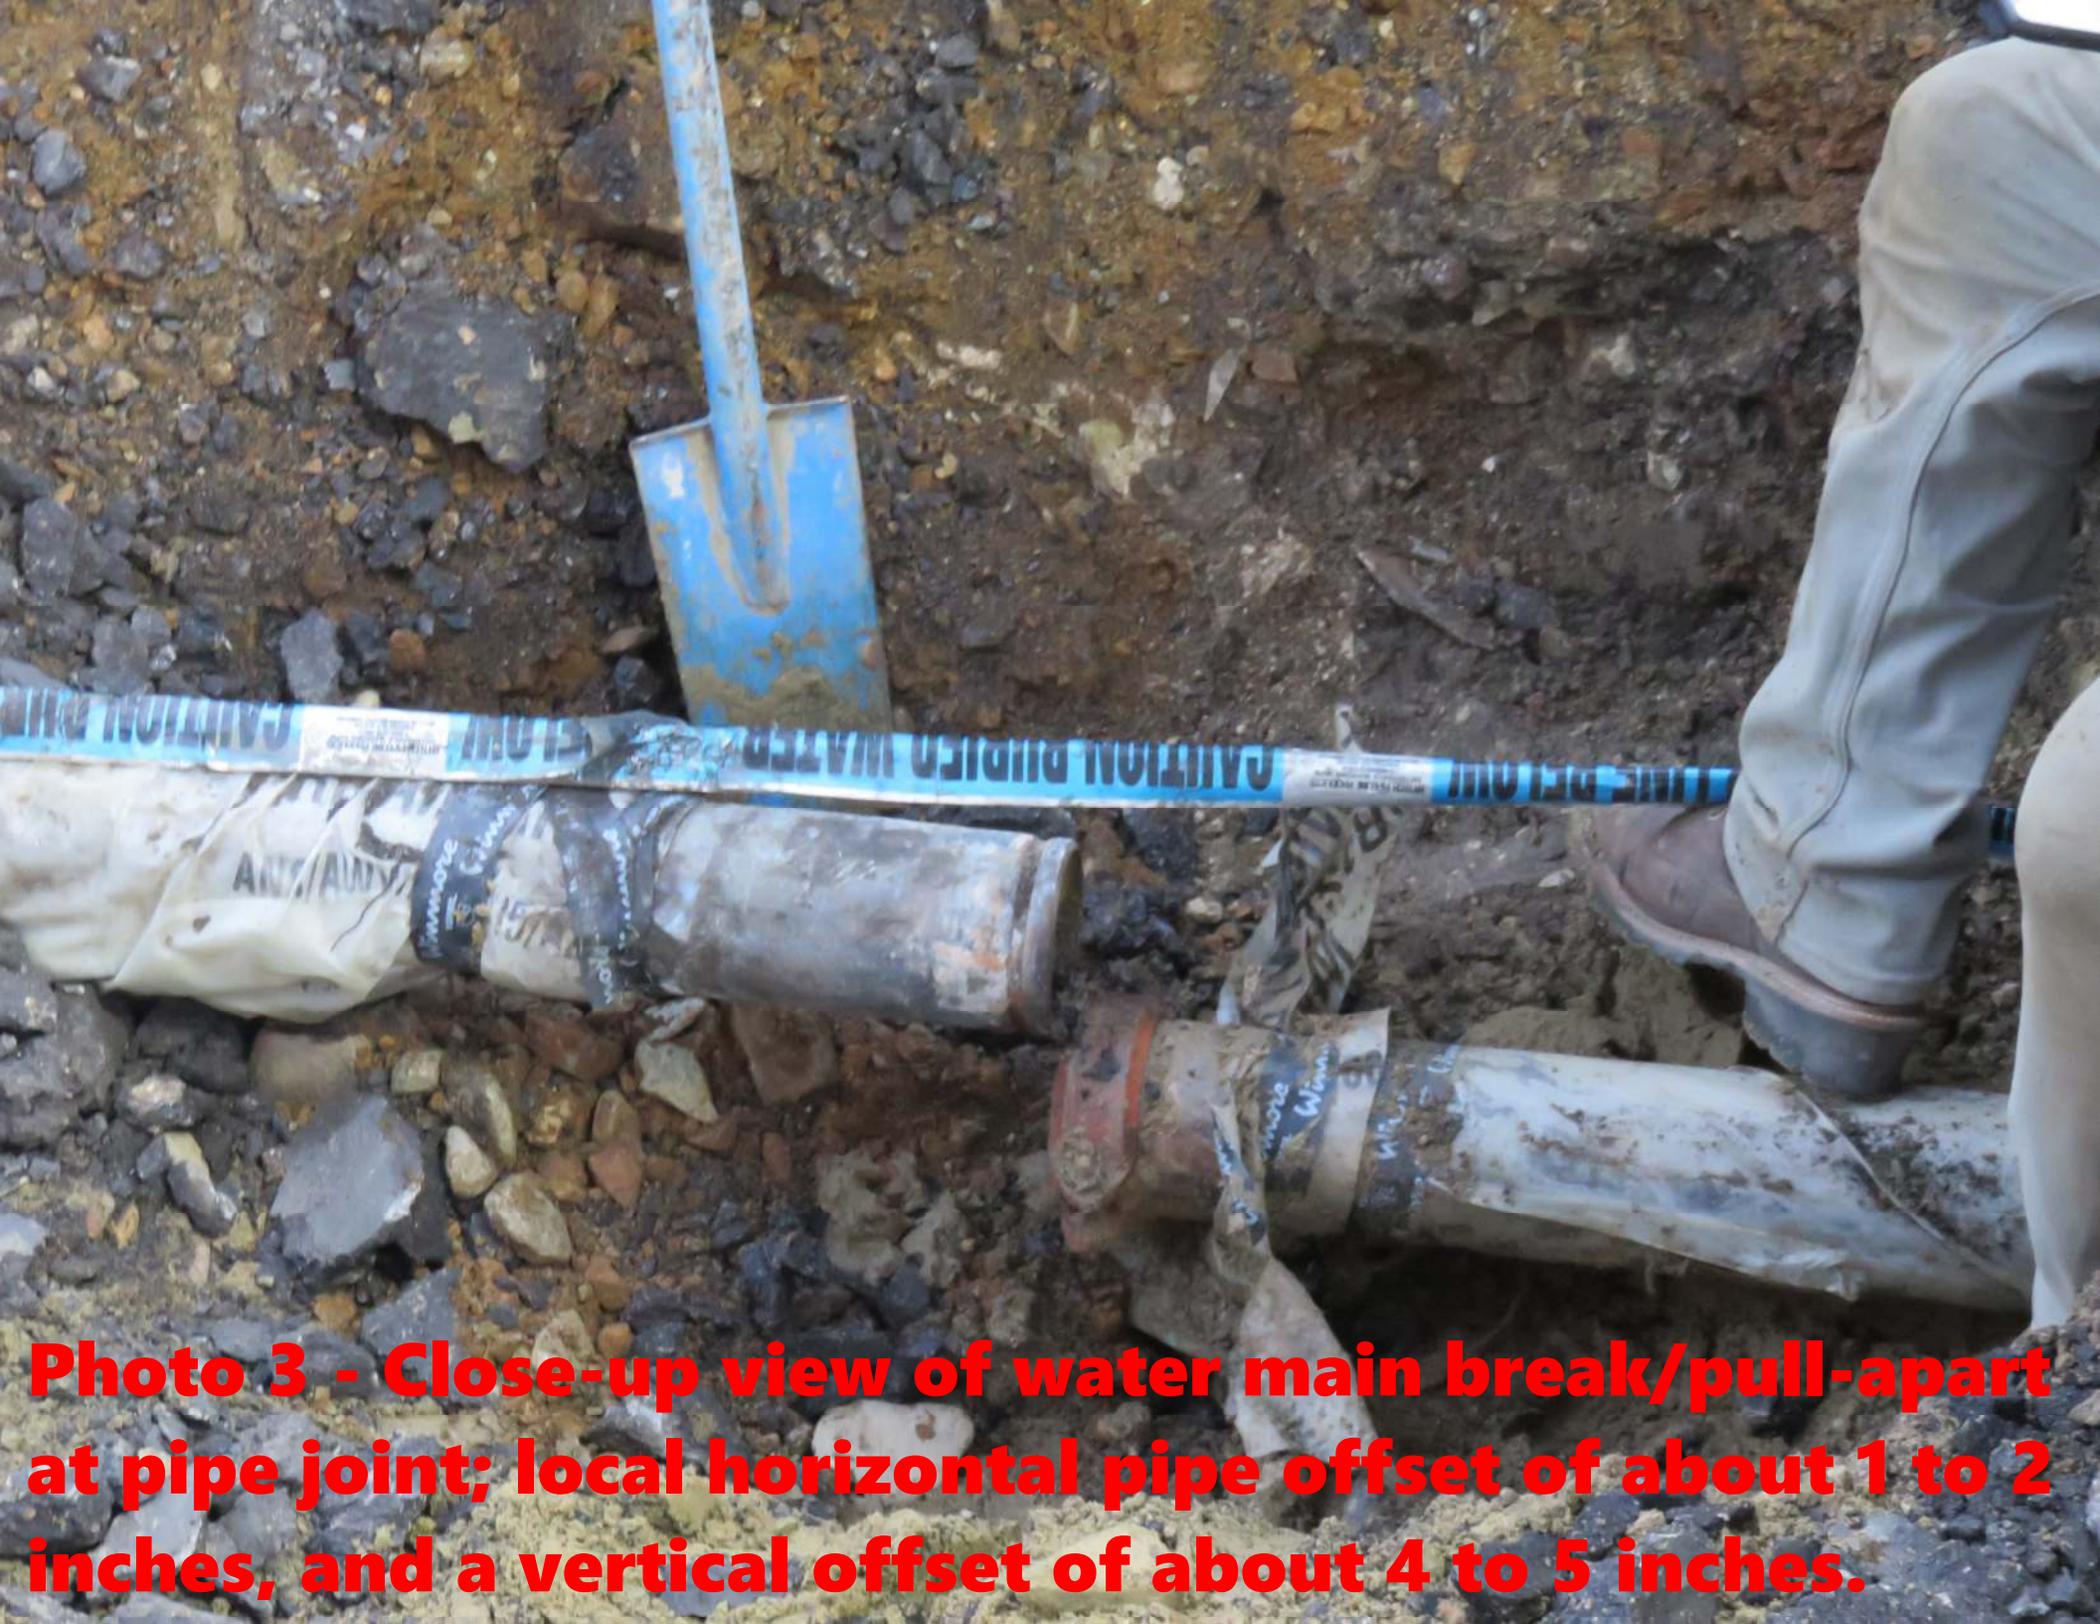
Photo 3 - Close-up view of water main break/pull-apart at pipe joint; local horizontal pipe offset of about 1 to 2 inches, and a vertical offset of about 4 to 5 inches.

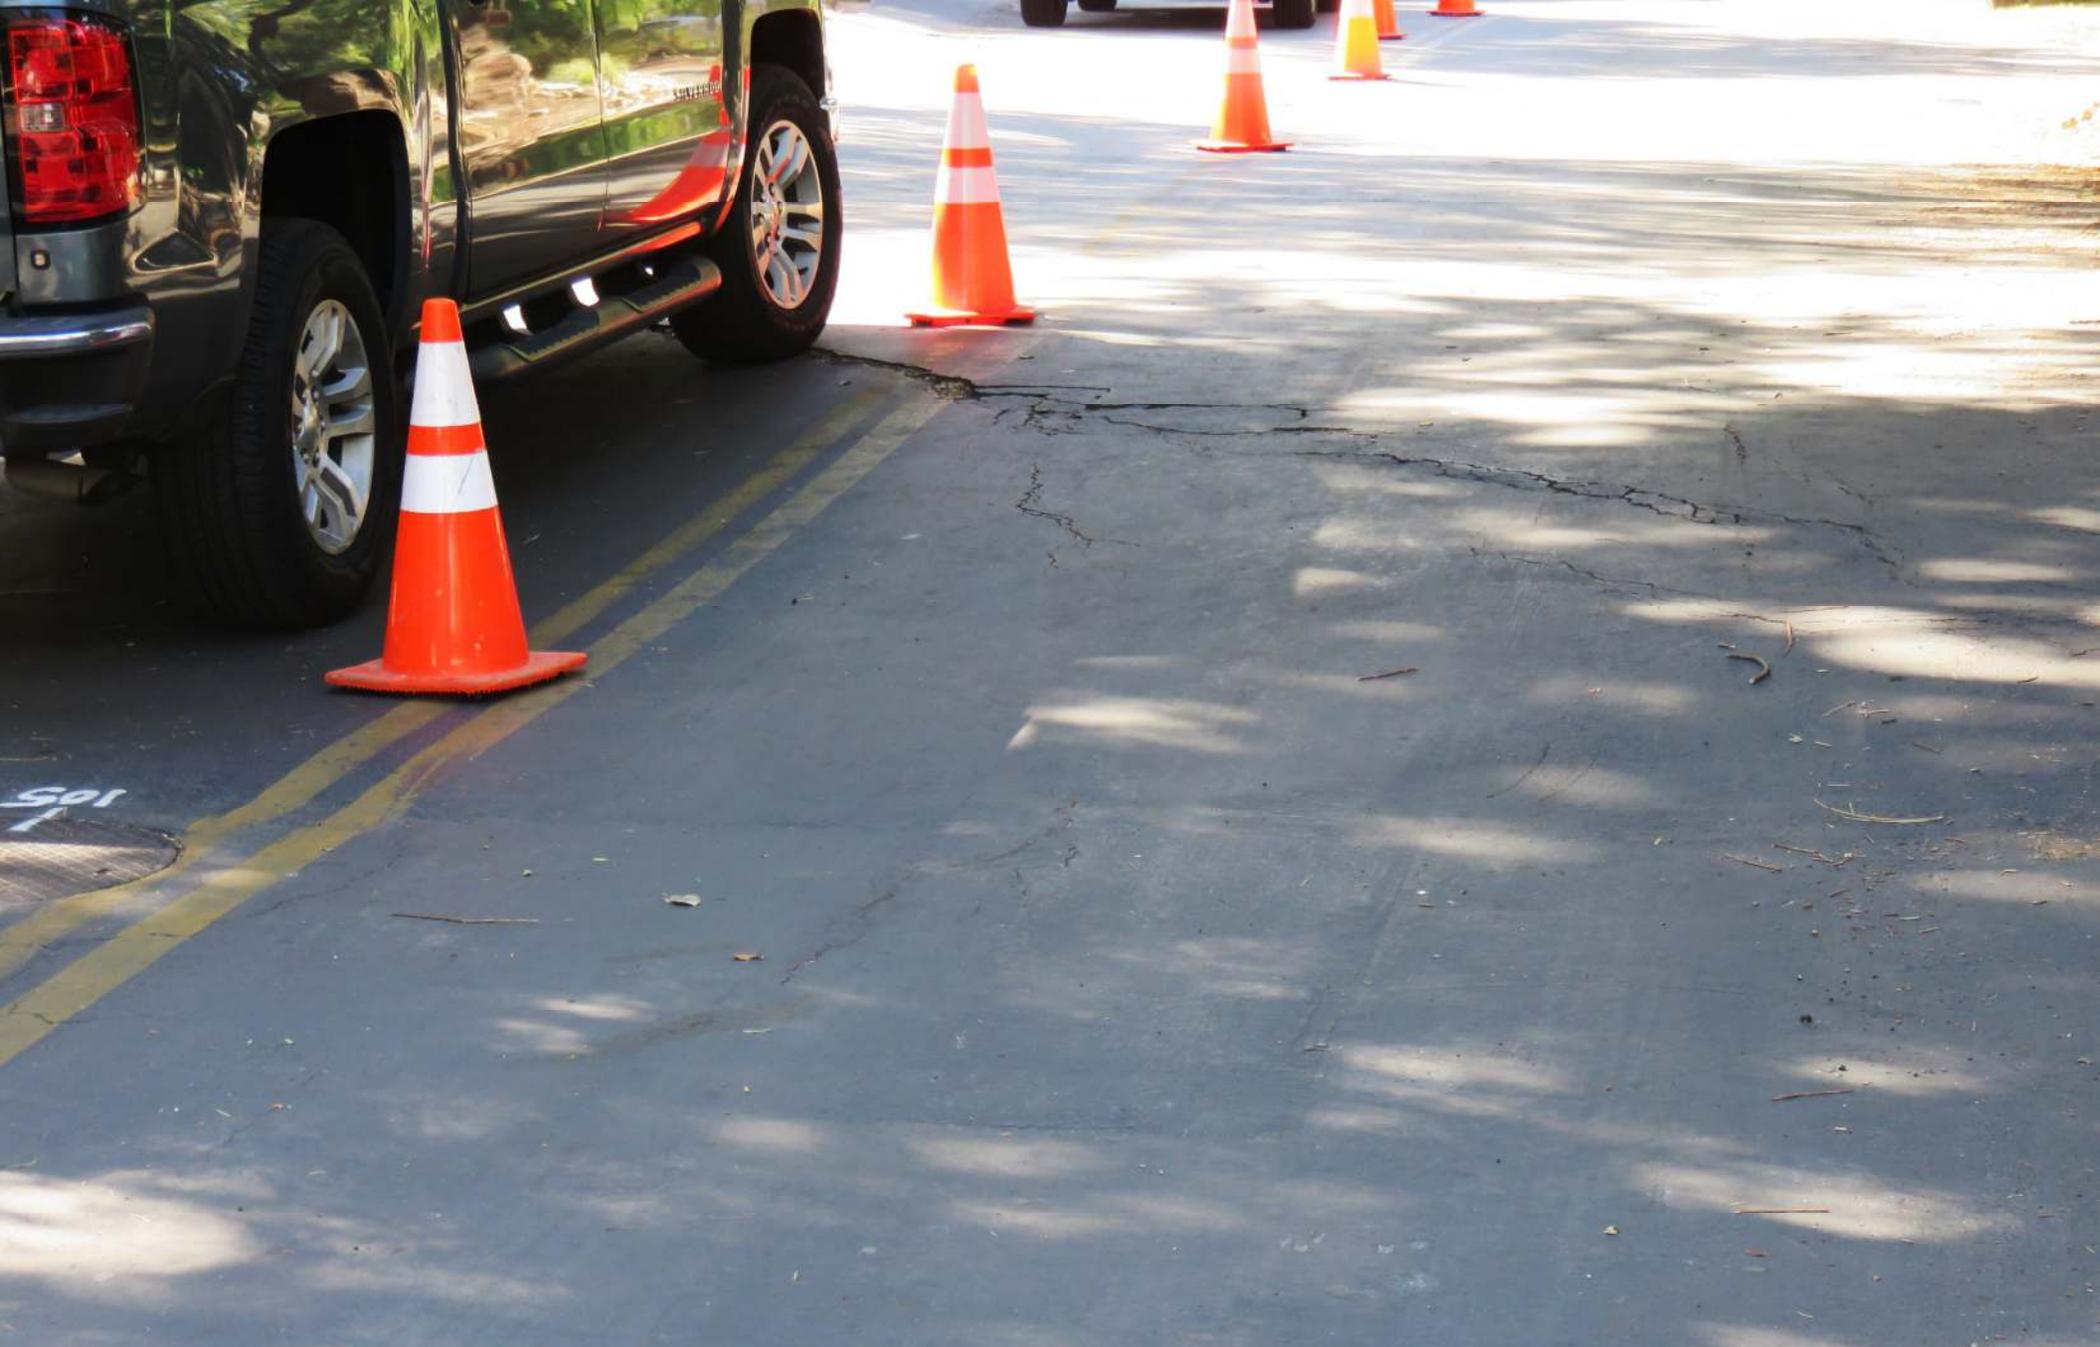
Previously observed subtle elevation differentials across the east-west trending zones of tension cracking in the Cinnamon Lane and Clovetree Place pavement were noticeably larger, to the extent that reduced speed would be advisable for car travel across the ground deformation areas in the two roadways. The down-dropped areas on the southerly sides of the tension cracking zones are spread across several feet with an estimated total elevation difference of about 3 to 6 inches along Cinnamon Lane and about 6 to 12 inches along Clovetree Place. In the immediate vicinity of the recent water main break beneath Clovetree Place, the down-dropped area forms a local trough near the edge of the pavement that appears to be about 12 to 16 inches below the adjacent roadway surface on the northerly side of the tension cracking zone. The actual tension cracks crossing Clovetree Place were obscured by equipment, vehicles, and excavated soils associated with repairs that were in progress at the time of the site review. Although the tension cracking zone across Cinnamon Lane was also locally obscured by repair vehicles, the exposed easterly portion of the zone showed relatively minor changes from the previous site visit that were essentially limited to a few additional fractures, minor local dilation of the previously observed fractures and a small local elevation difference across some fractures that appeared to be less than about ¼-inch (south side down, refer to site plan distress plot and Photo 4).

Photo 4 - View northeast at tension crack zone and subtle landslide scarp crossing Cinnamon Lane between Lots 9 and 16, with slight vertical offset on some cracks.

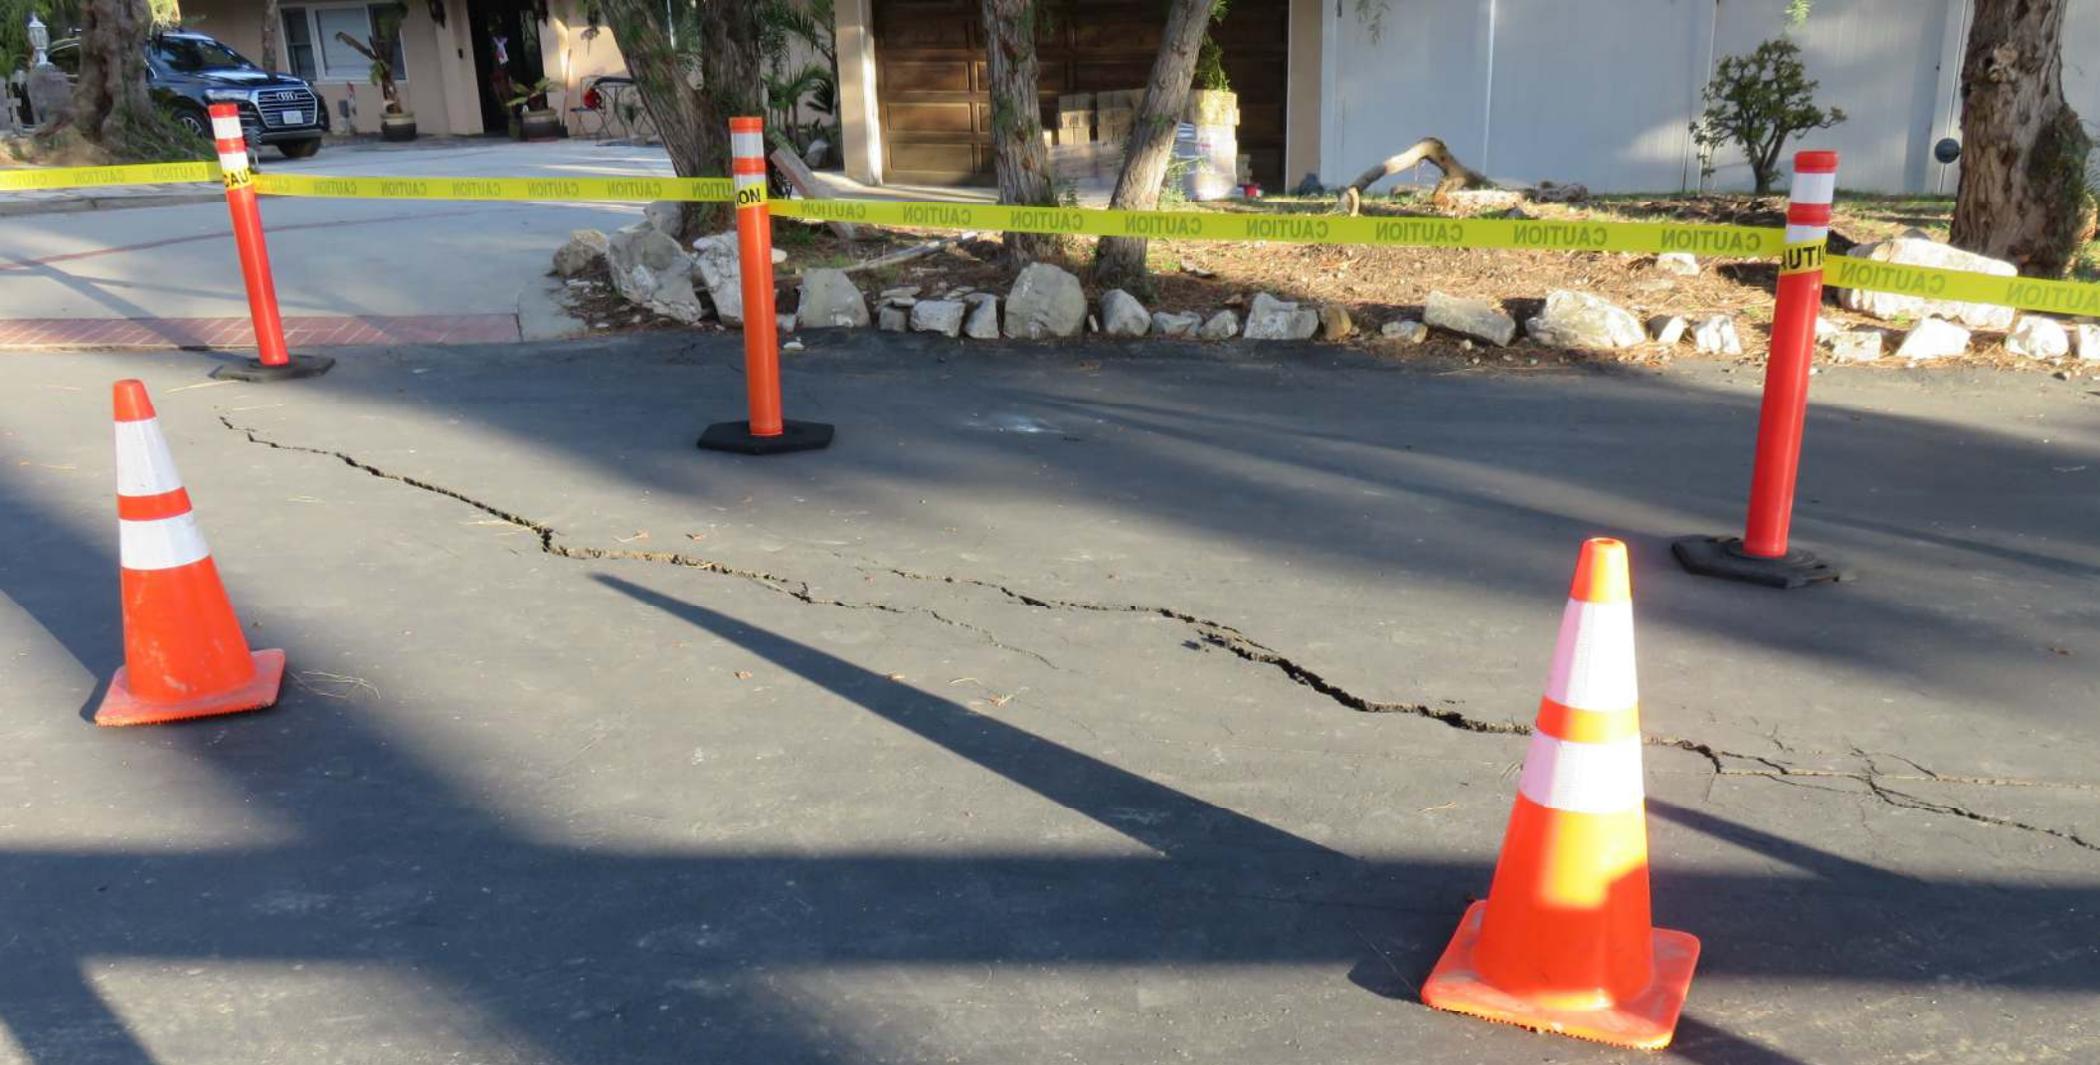
Photo 5 - View southeast across the shallow trough (small landslide graben) in Clovetree Place pavement; the tension crack zone forms the south side of the shallow trough/graben in pavement (north side down offset); the west driveway on Lot 9 is in the background.

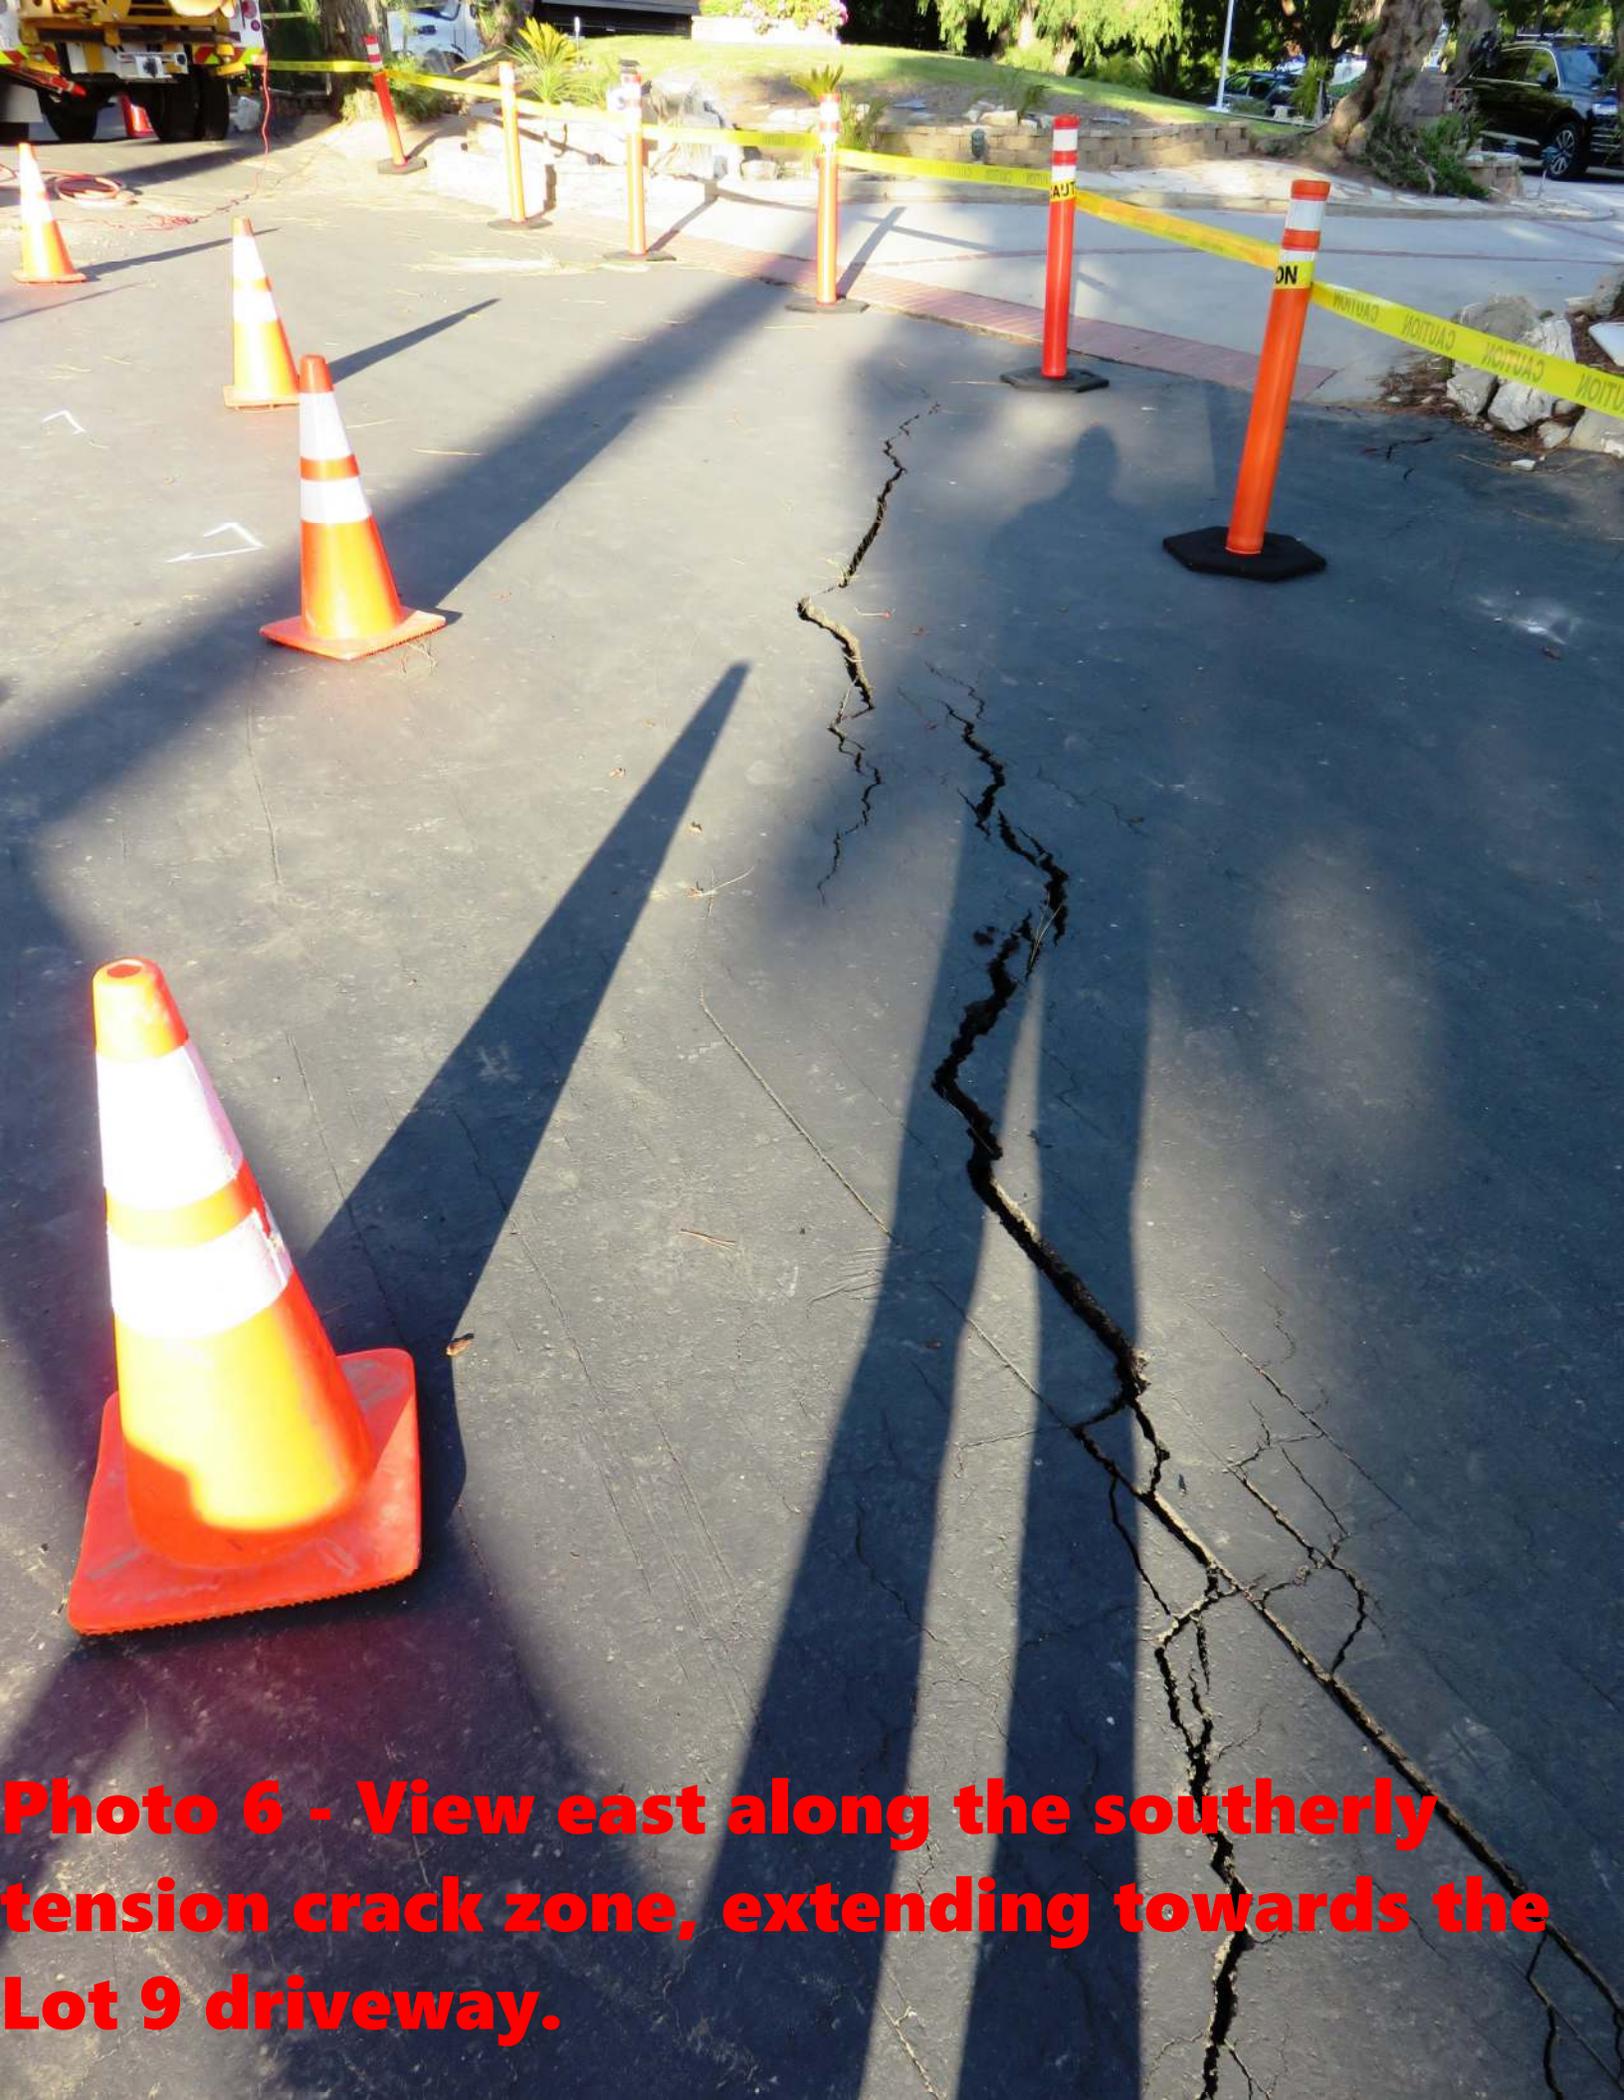
Photo 6 - View east along the southerly tension crack zone, extending towards the Lot 9 driveway.

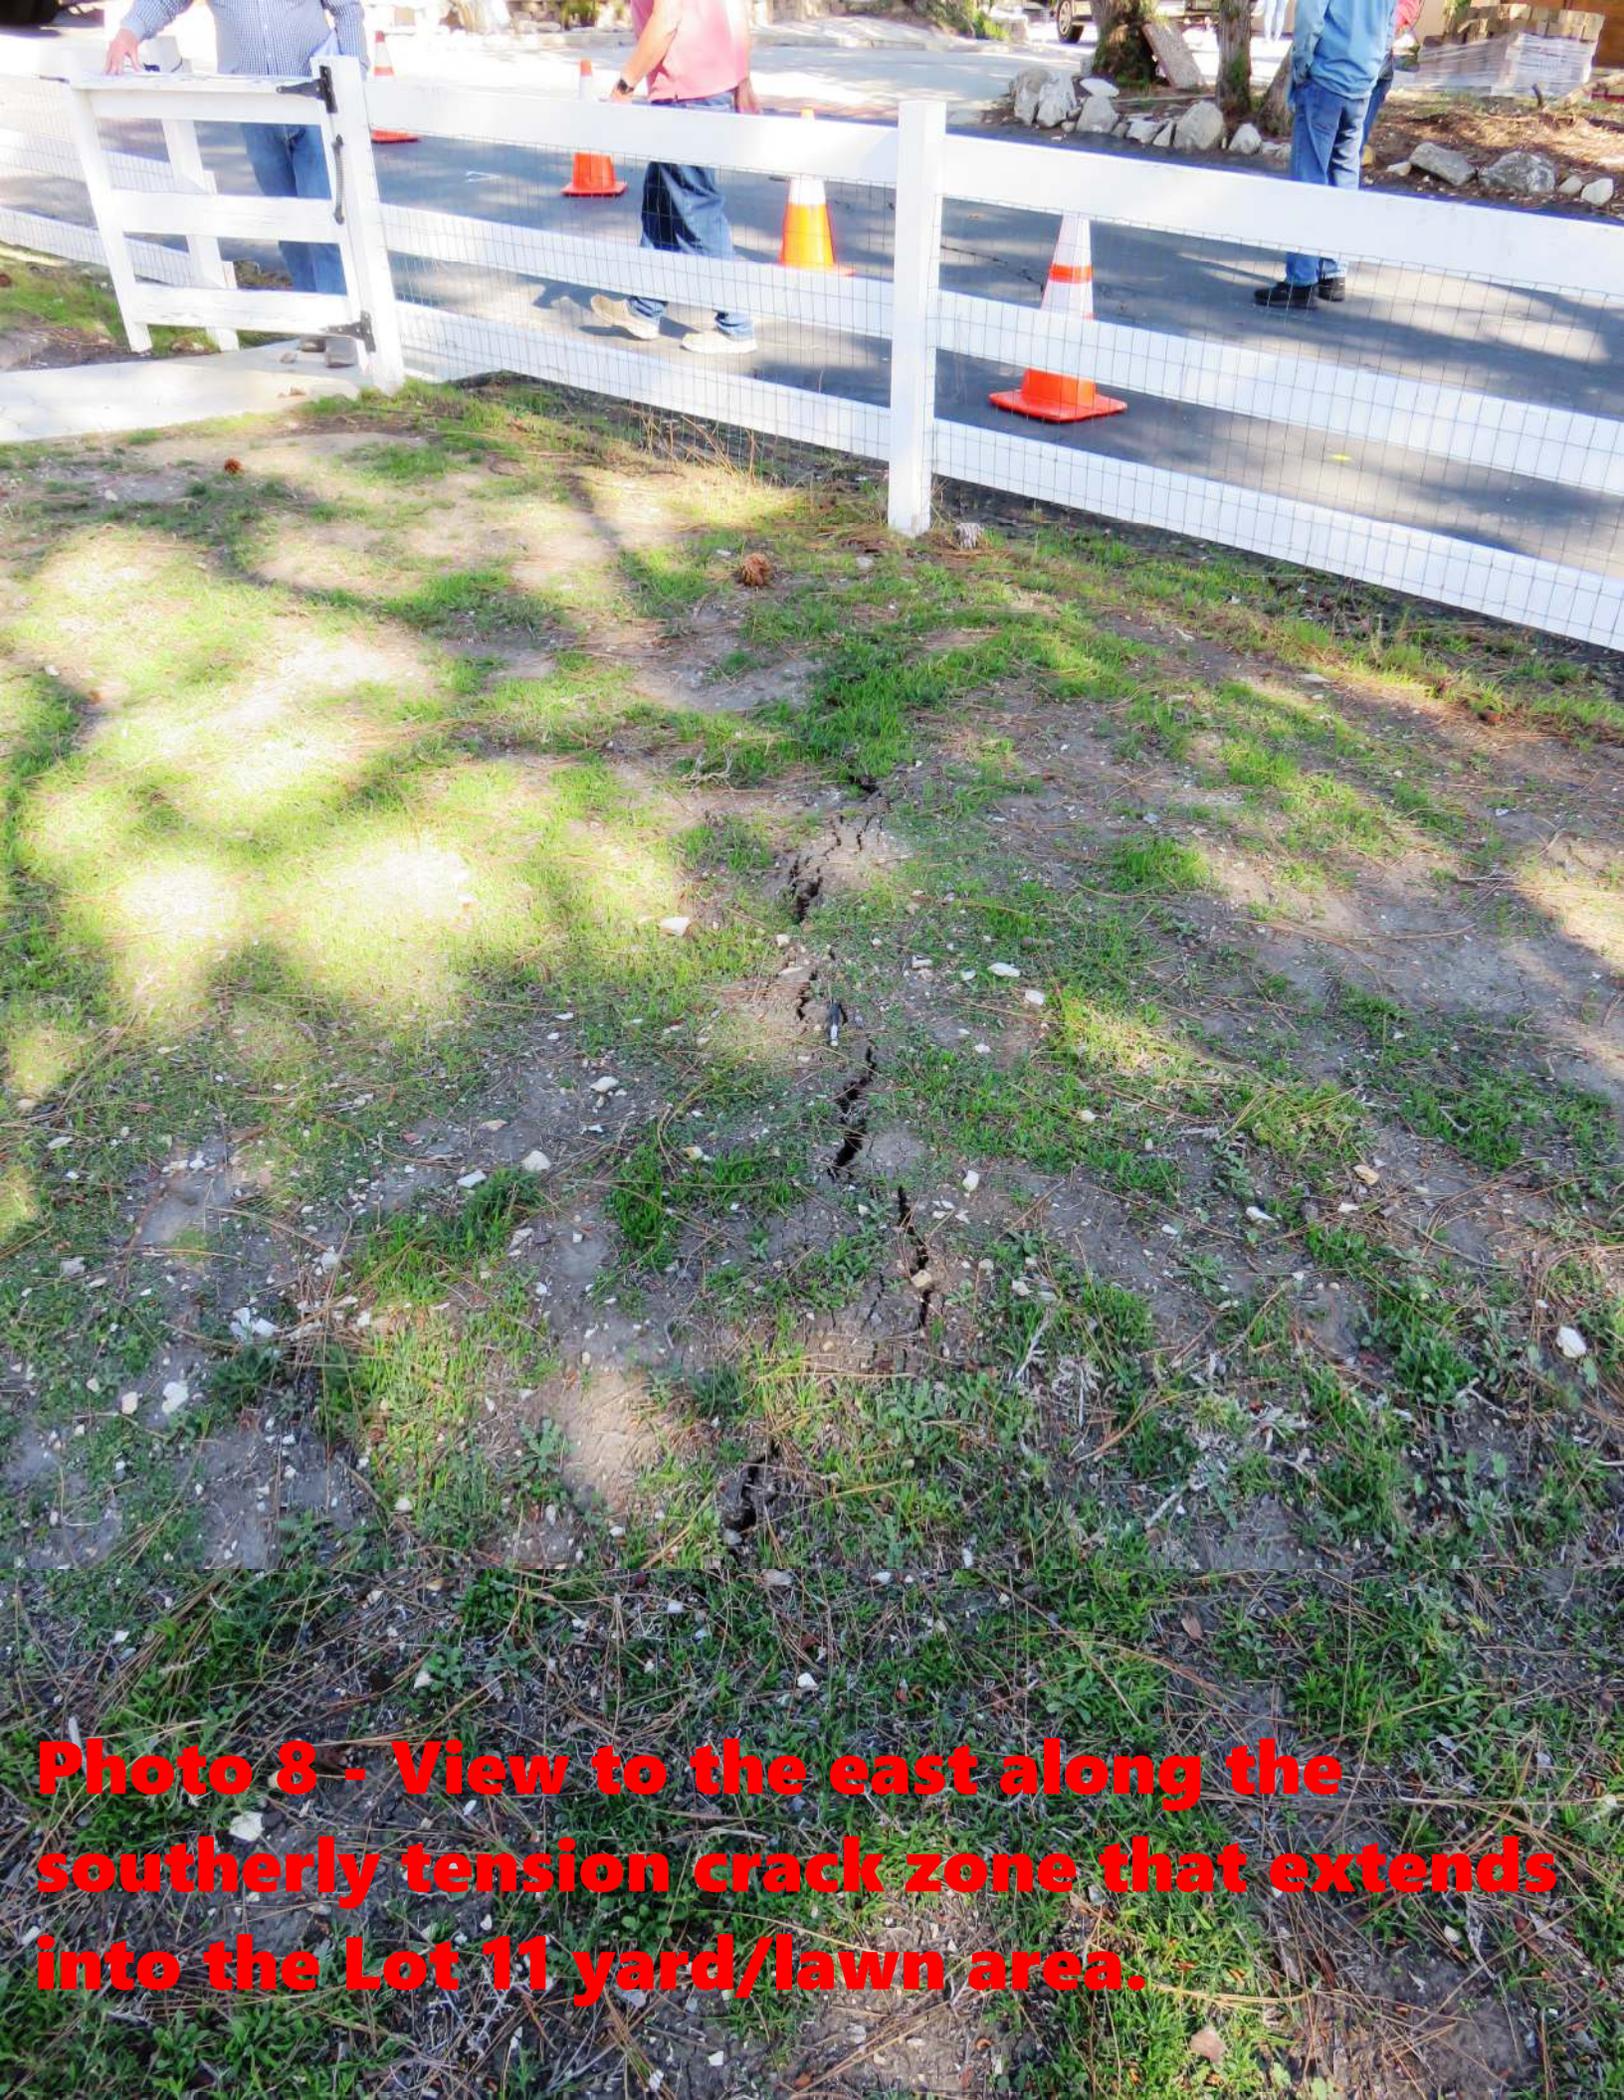
The parallel sets of tension cracks crossing Clovetree Place were also observed extending to the west about 15 to 20 feet across the front lawn on Lot 11 (Photos 8 and 9). Although vertical offsets across these ground cracks were generally not distinct, the overall ground surface, and deformation of the perimeter fence and concrete walkway in this portion of the lot suggest the presence of a subtle trough between the fracture zones (Photo 10).

Photo 8 - View to the east along the southerly tension crack zone that extends into the Lot 11 yard/lawn area.
