4/15/2021

Abalone Cove Landslide Abatement District
P.O. Box 3675
Palos Verdes Peninsula, CA 90274.
Attention: Tim Kelly and Michael Barth

**Second Site Meeting and Review Re: Ground Deformation/Local Damage
Near Intersection of Cinnamon Lane and Clove Tree Place
Abalone Cove Residential Area, Rancho Palos Verdes, California**

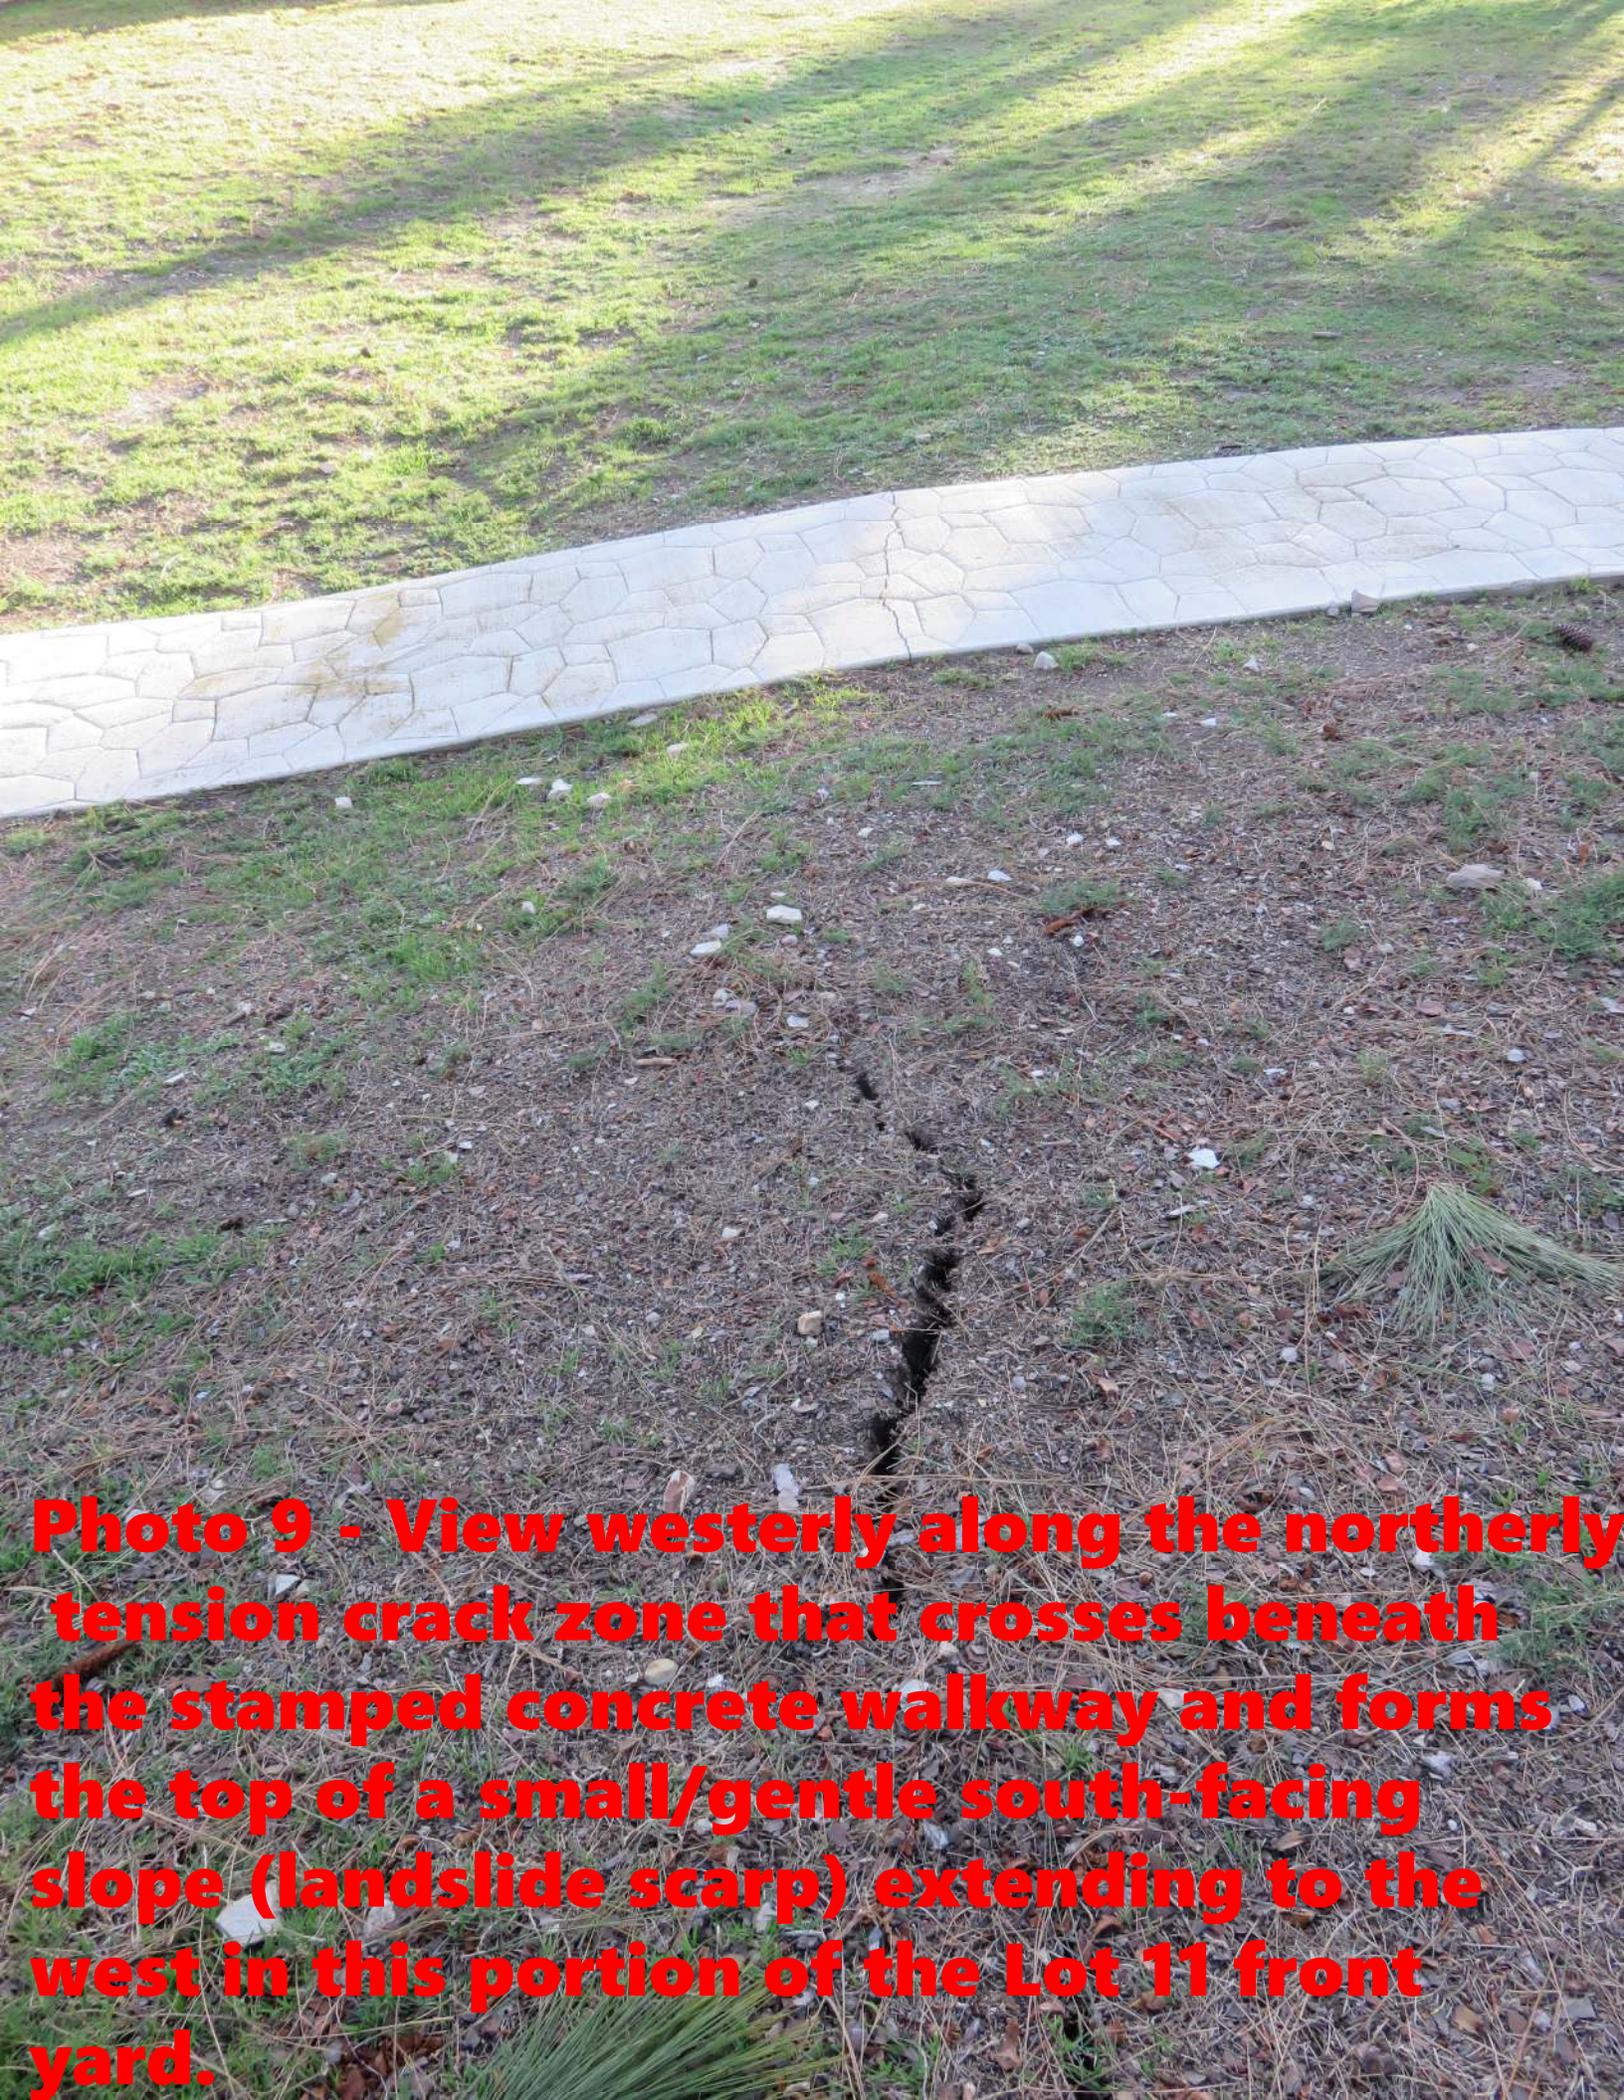
The parallel sets of tension cracks crossing Clovetree Place were also observed extending to the west about 15 to 20 feet across the front lawn on Lot 11 (Photos 8 and 9). Although vertical offsets across these ground cracks were generally not distinct, the overall ground surface, and deformation of the perimeter fence and concrete walkway in this portion of the lot suggest the presence of a subtle trough between the fracture zones (Photo 10).

Photo 9 - View westerly along the northerly tension crack zone that crosses beneath the stamped concrete walkway and forms the top of a small/gentle south-facing slope (landslide scarp) extending to the west in this portion of the Lot 11 front yard.

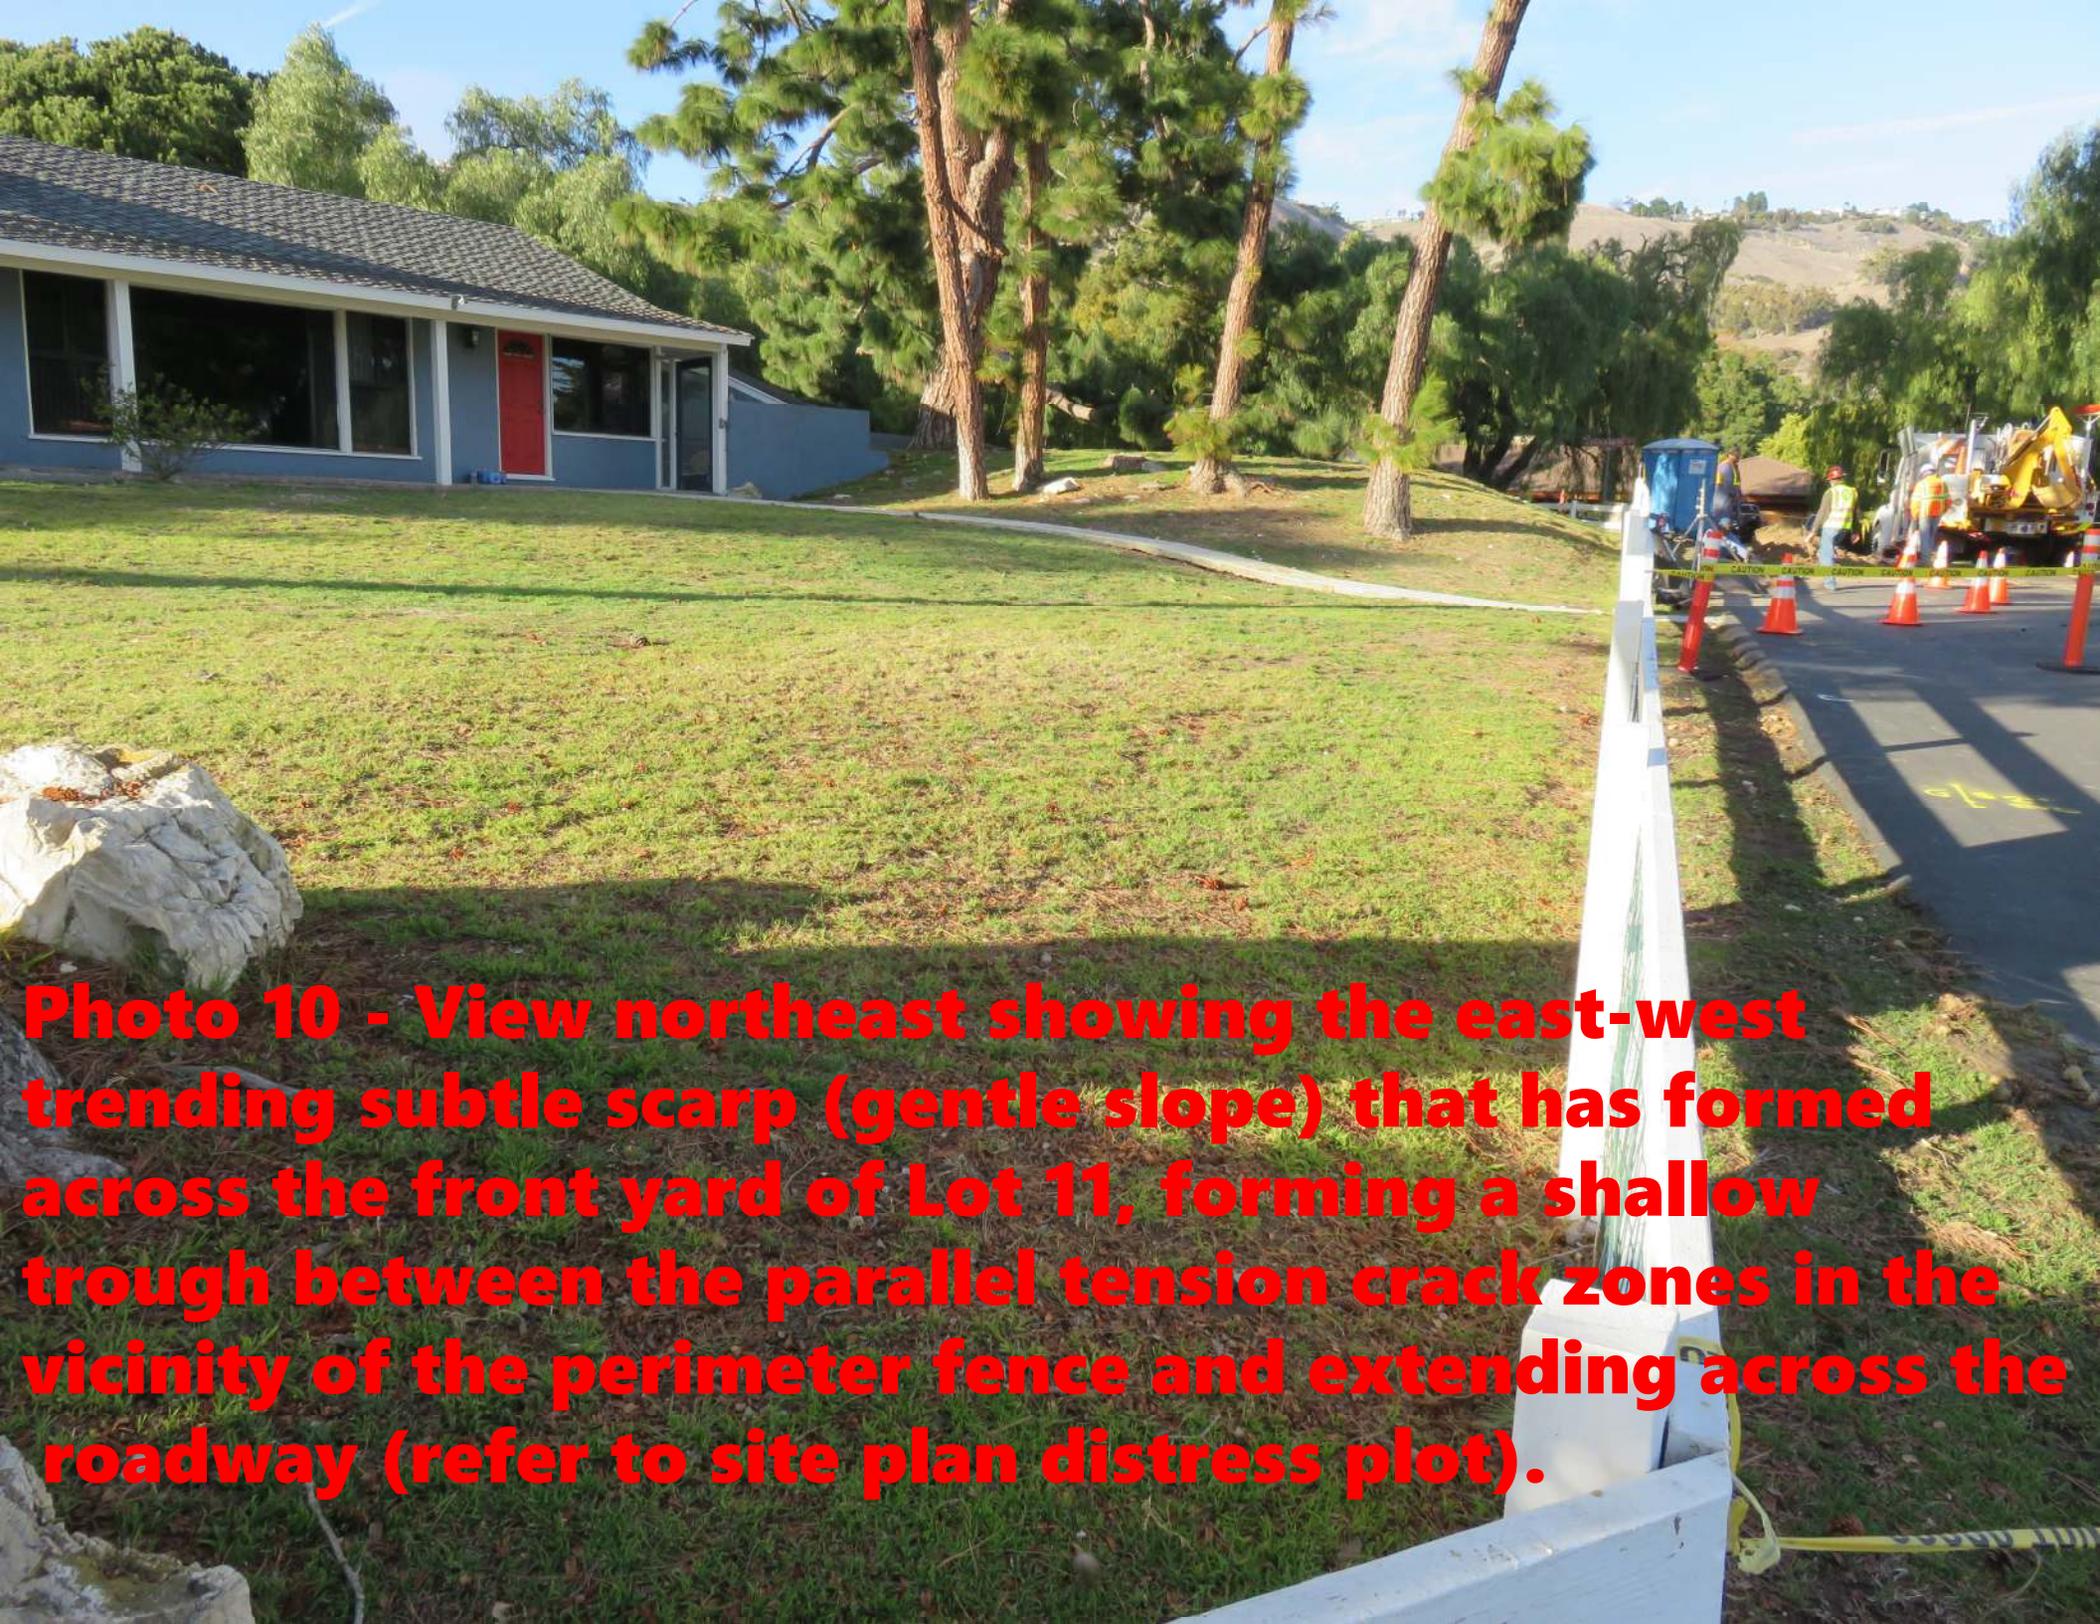
Photo 10 - View northeast showing the east-west trending subtle scarp (gentle slope) that has formed across the front yard of Lot 11, forming a shallow trough between the parallel tension crack zones in the vicinity of the perimeter fence and extending across the roadway (refer to site plan distress plot).

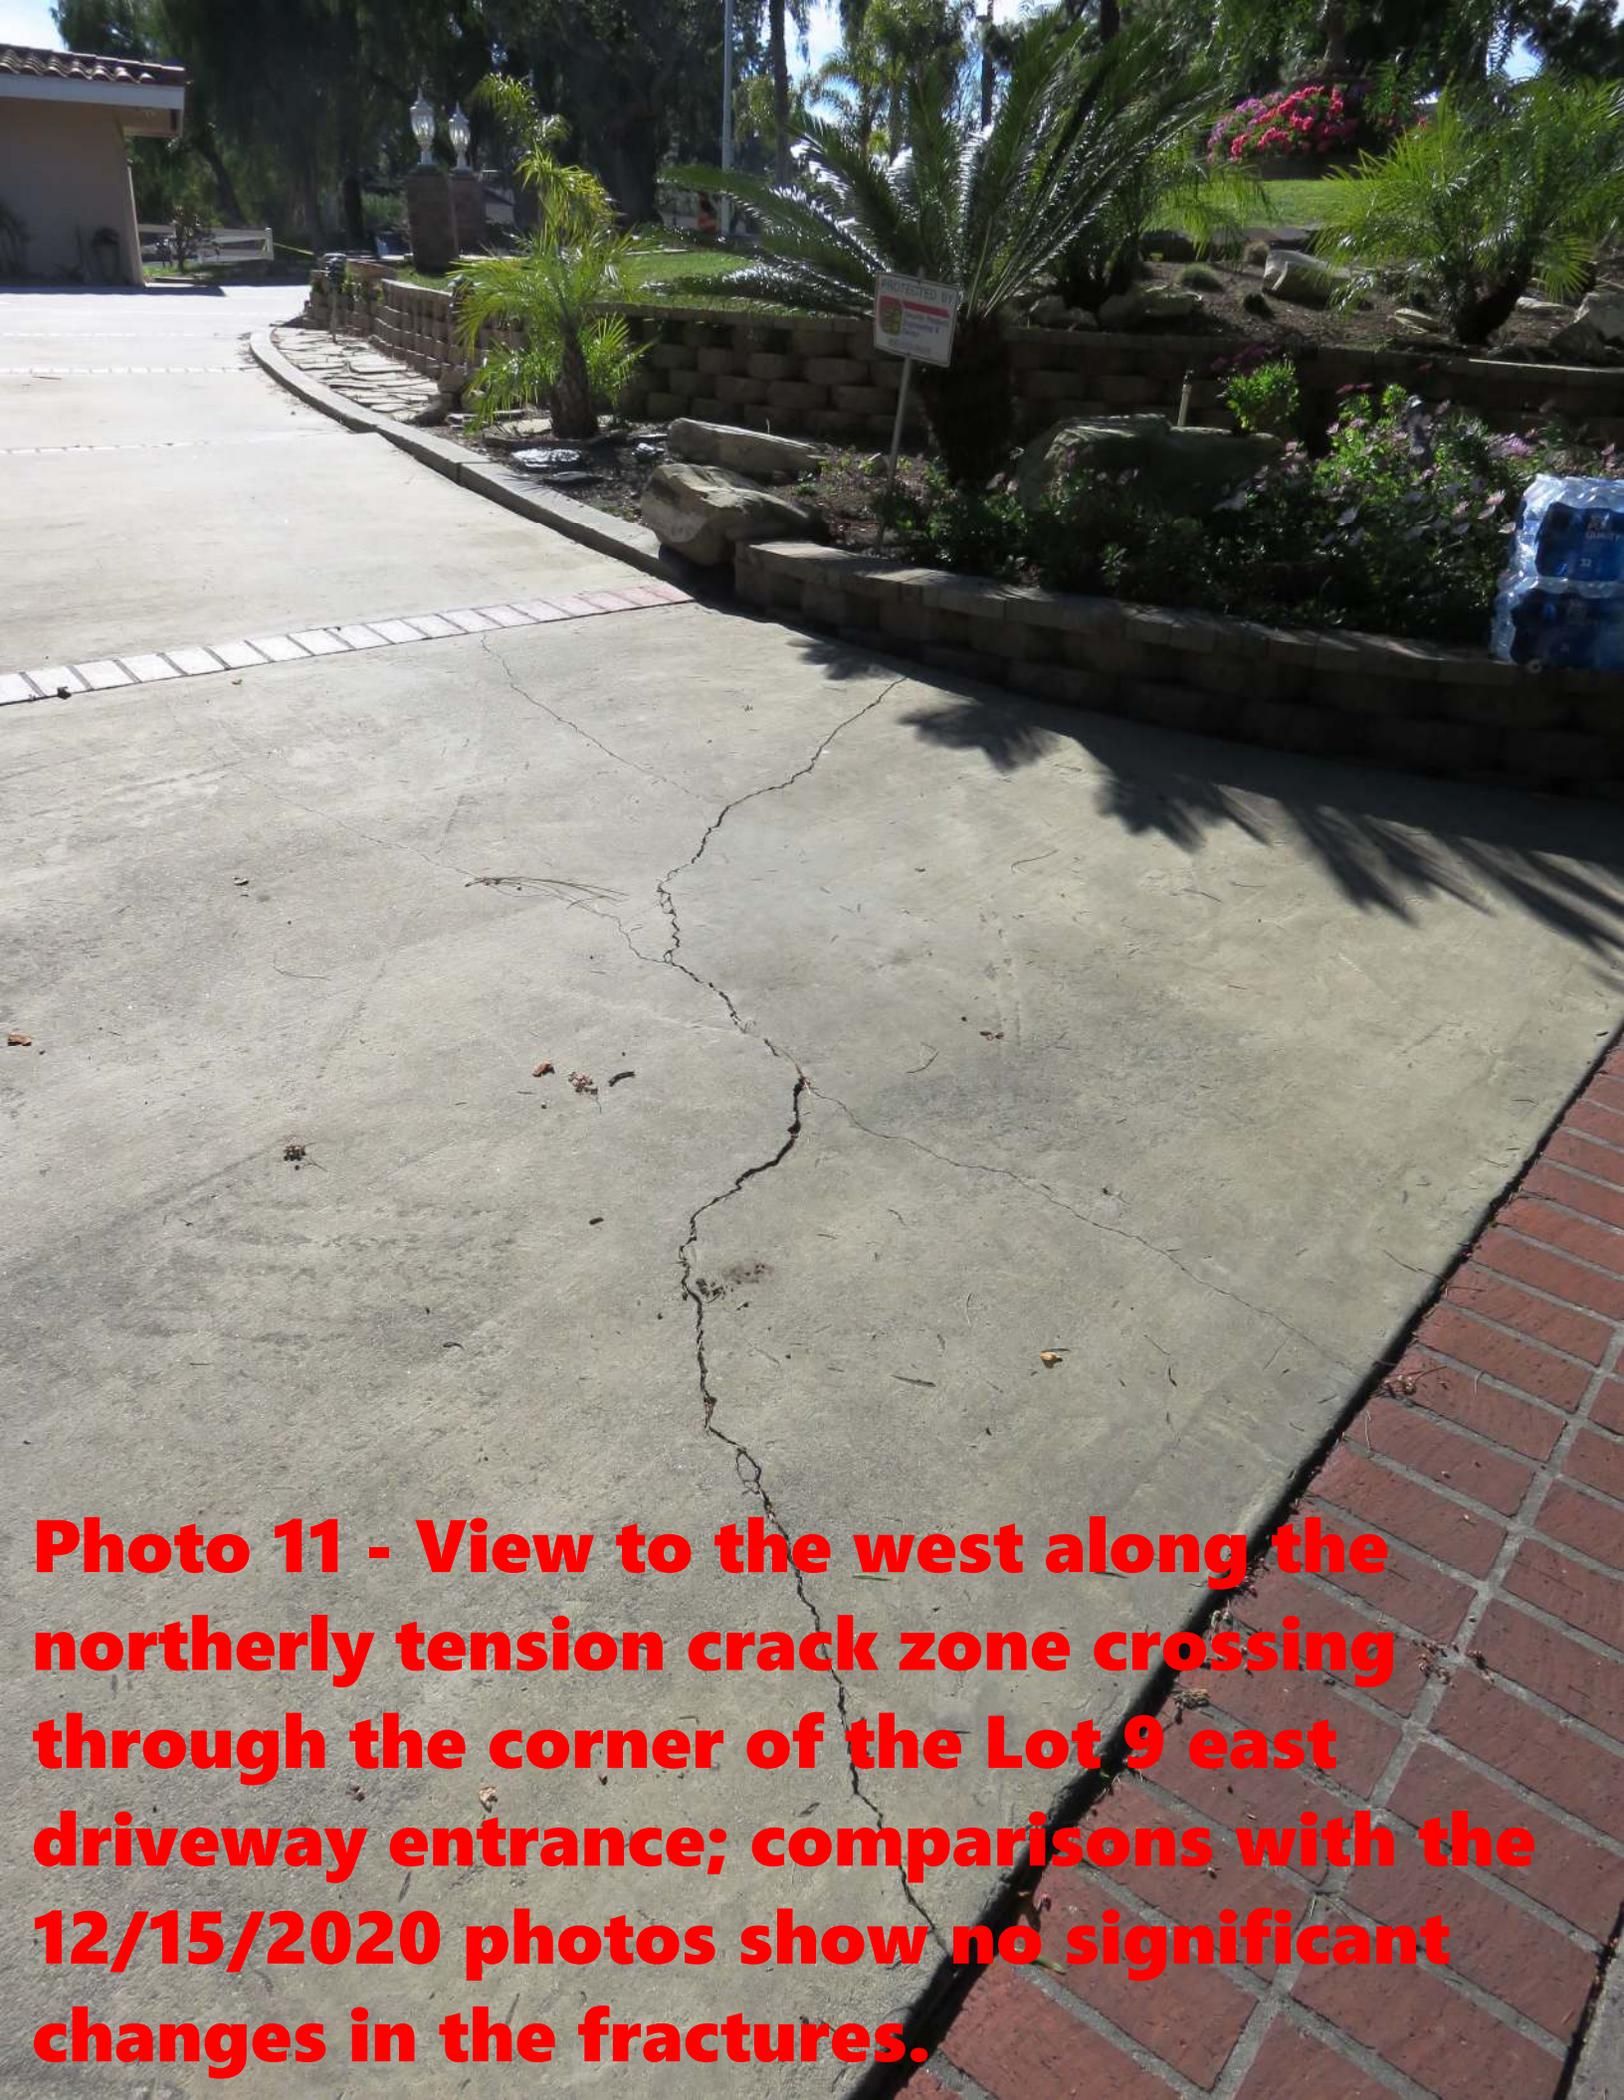
Photo 11 - View to the west along the northerly tension crack zone crossing through the corner of the Lot 9 east driveway entrance; comparisons with the 12/15/2020 photos show no significant changes in the fractures.

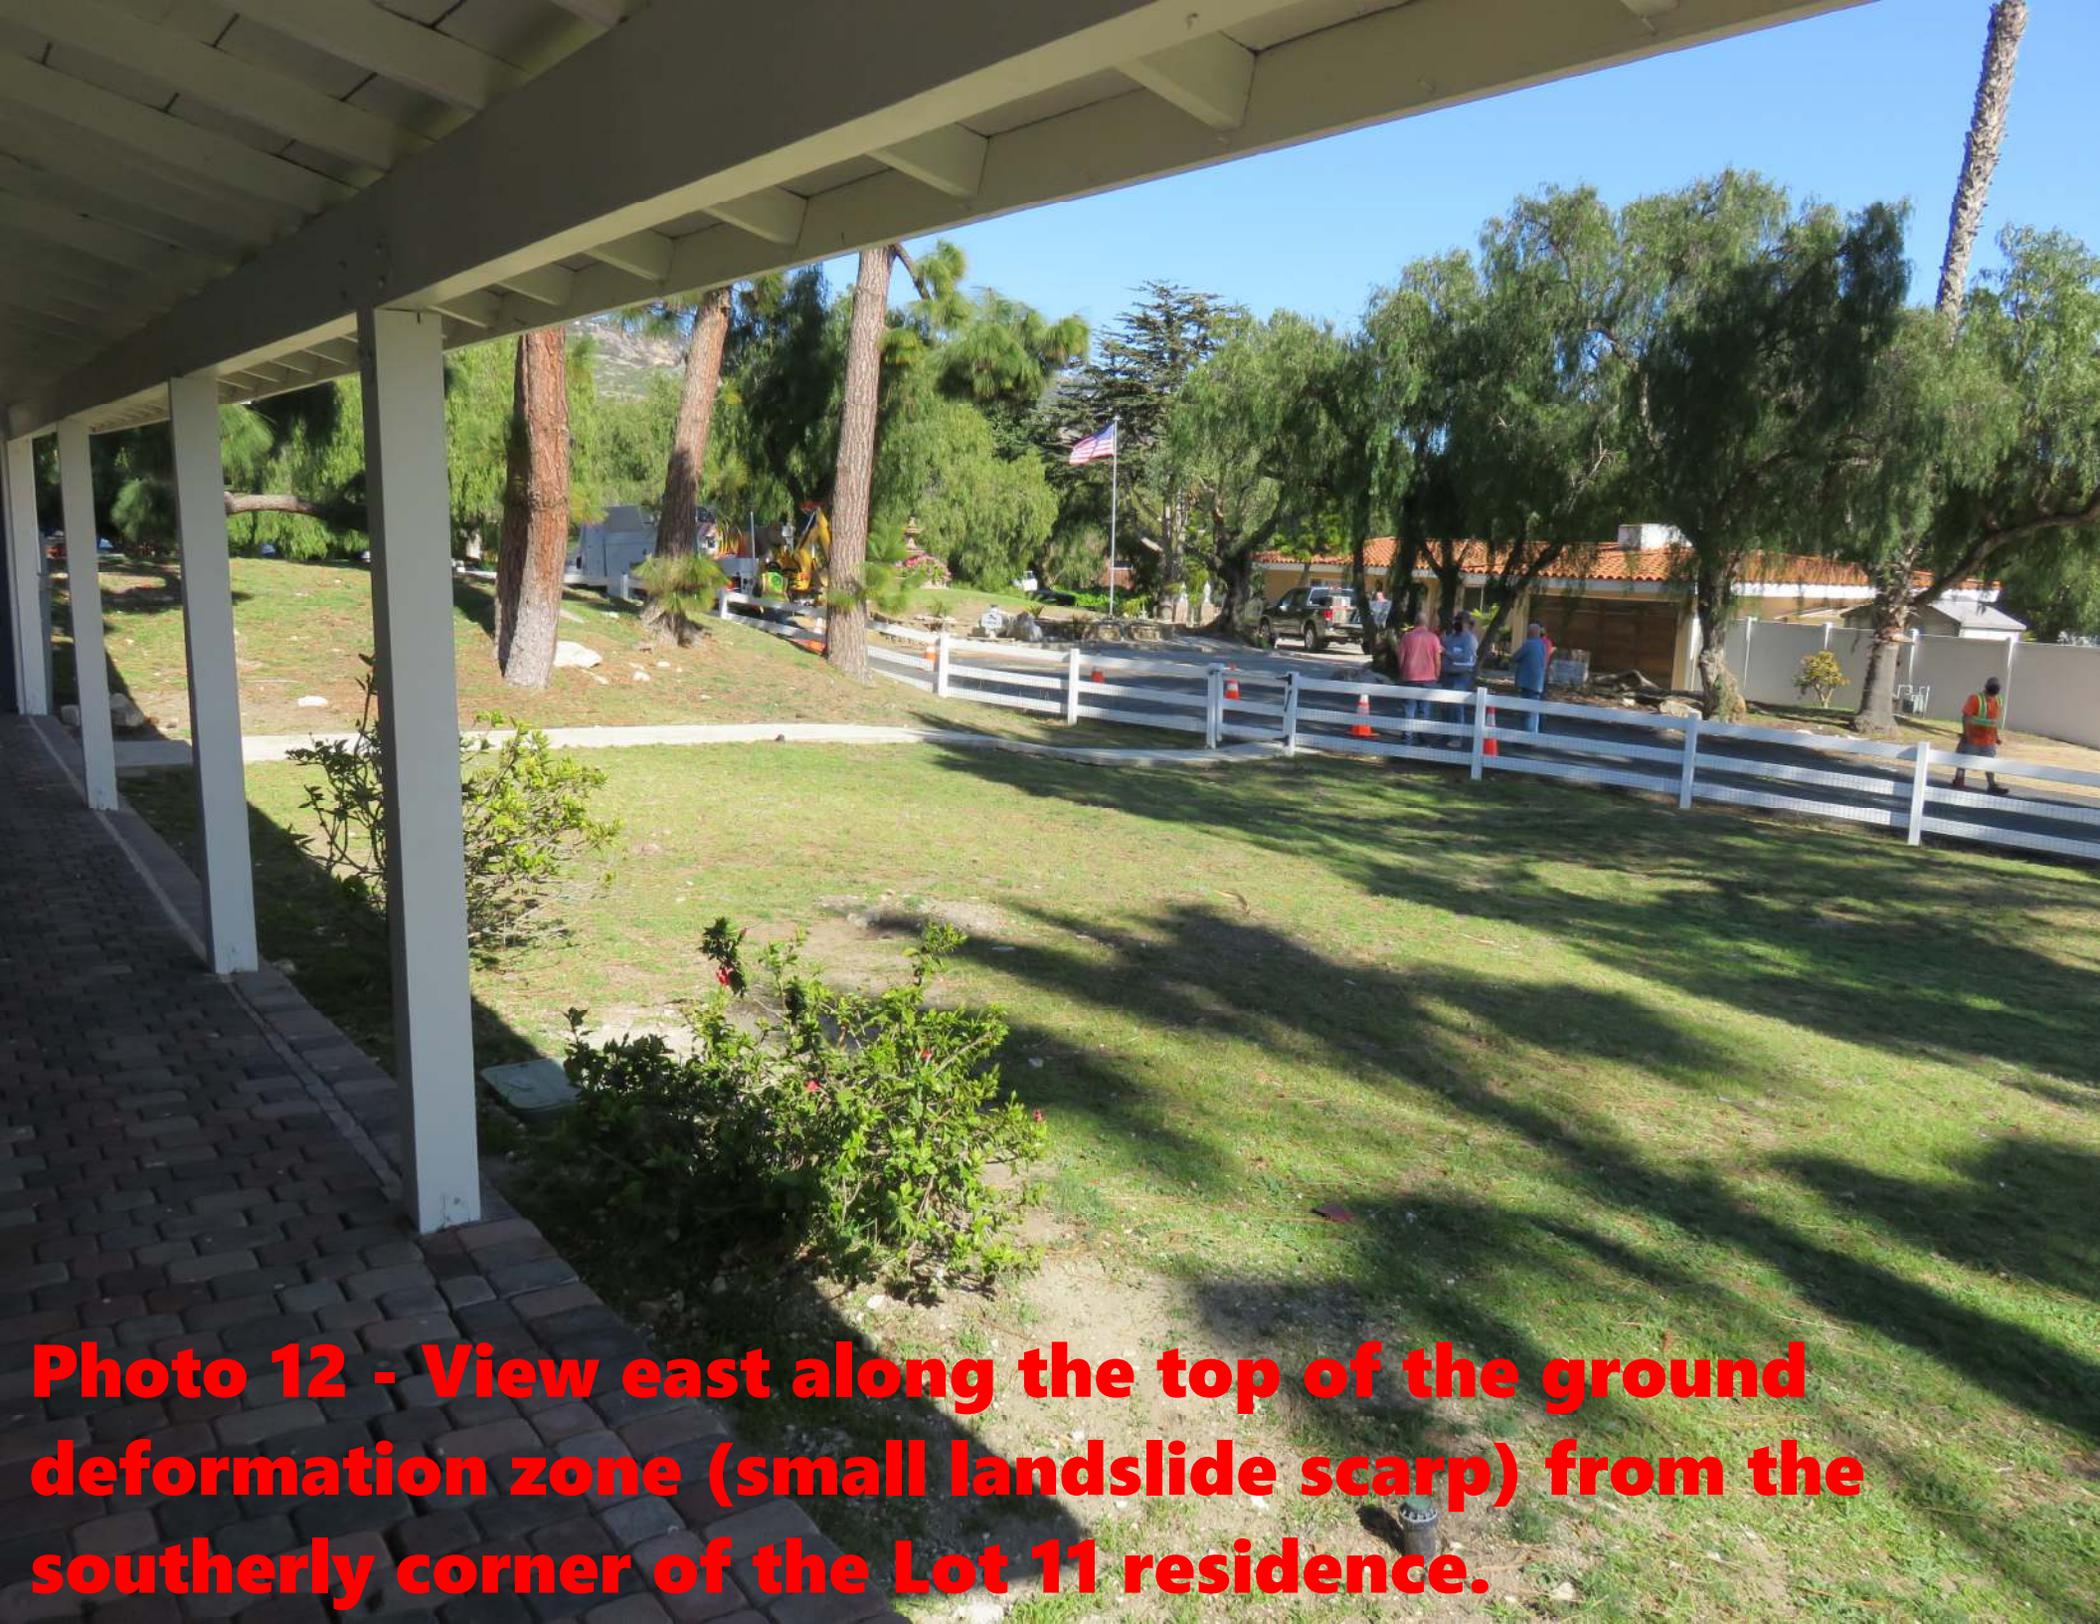
Photo 12 - View east along the top of the ground deformation zone (small landslide scarp) from the southerly corner of the Lot 11 residence.

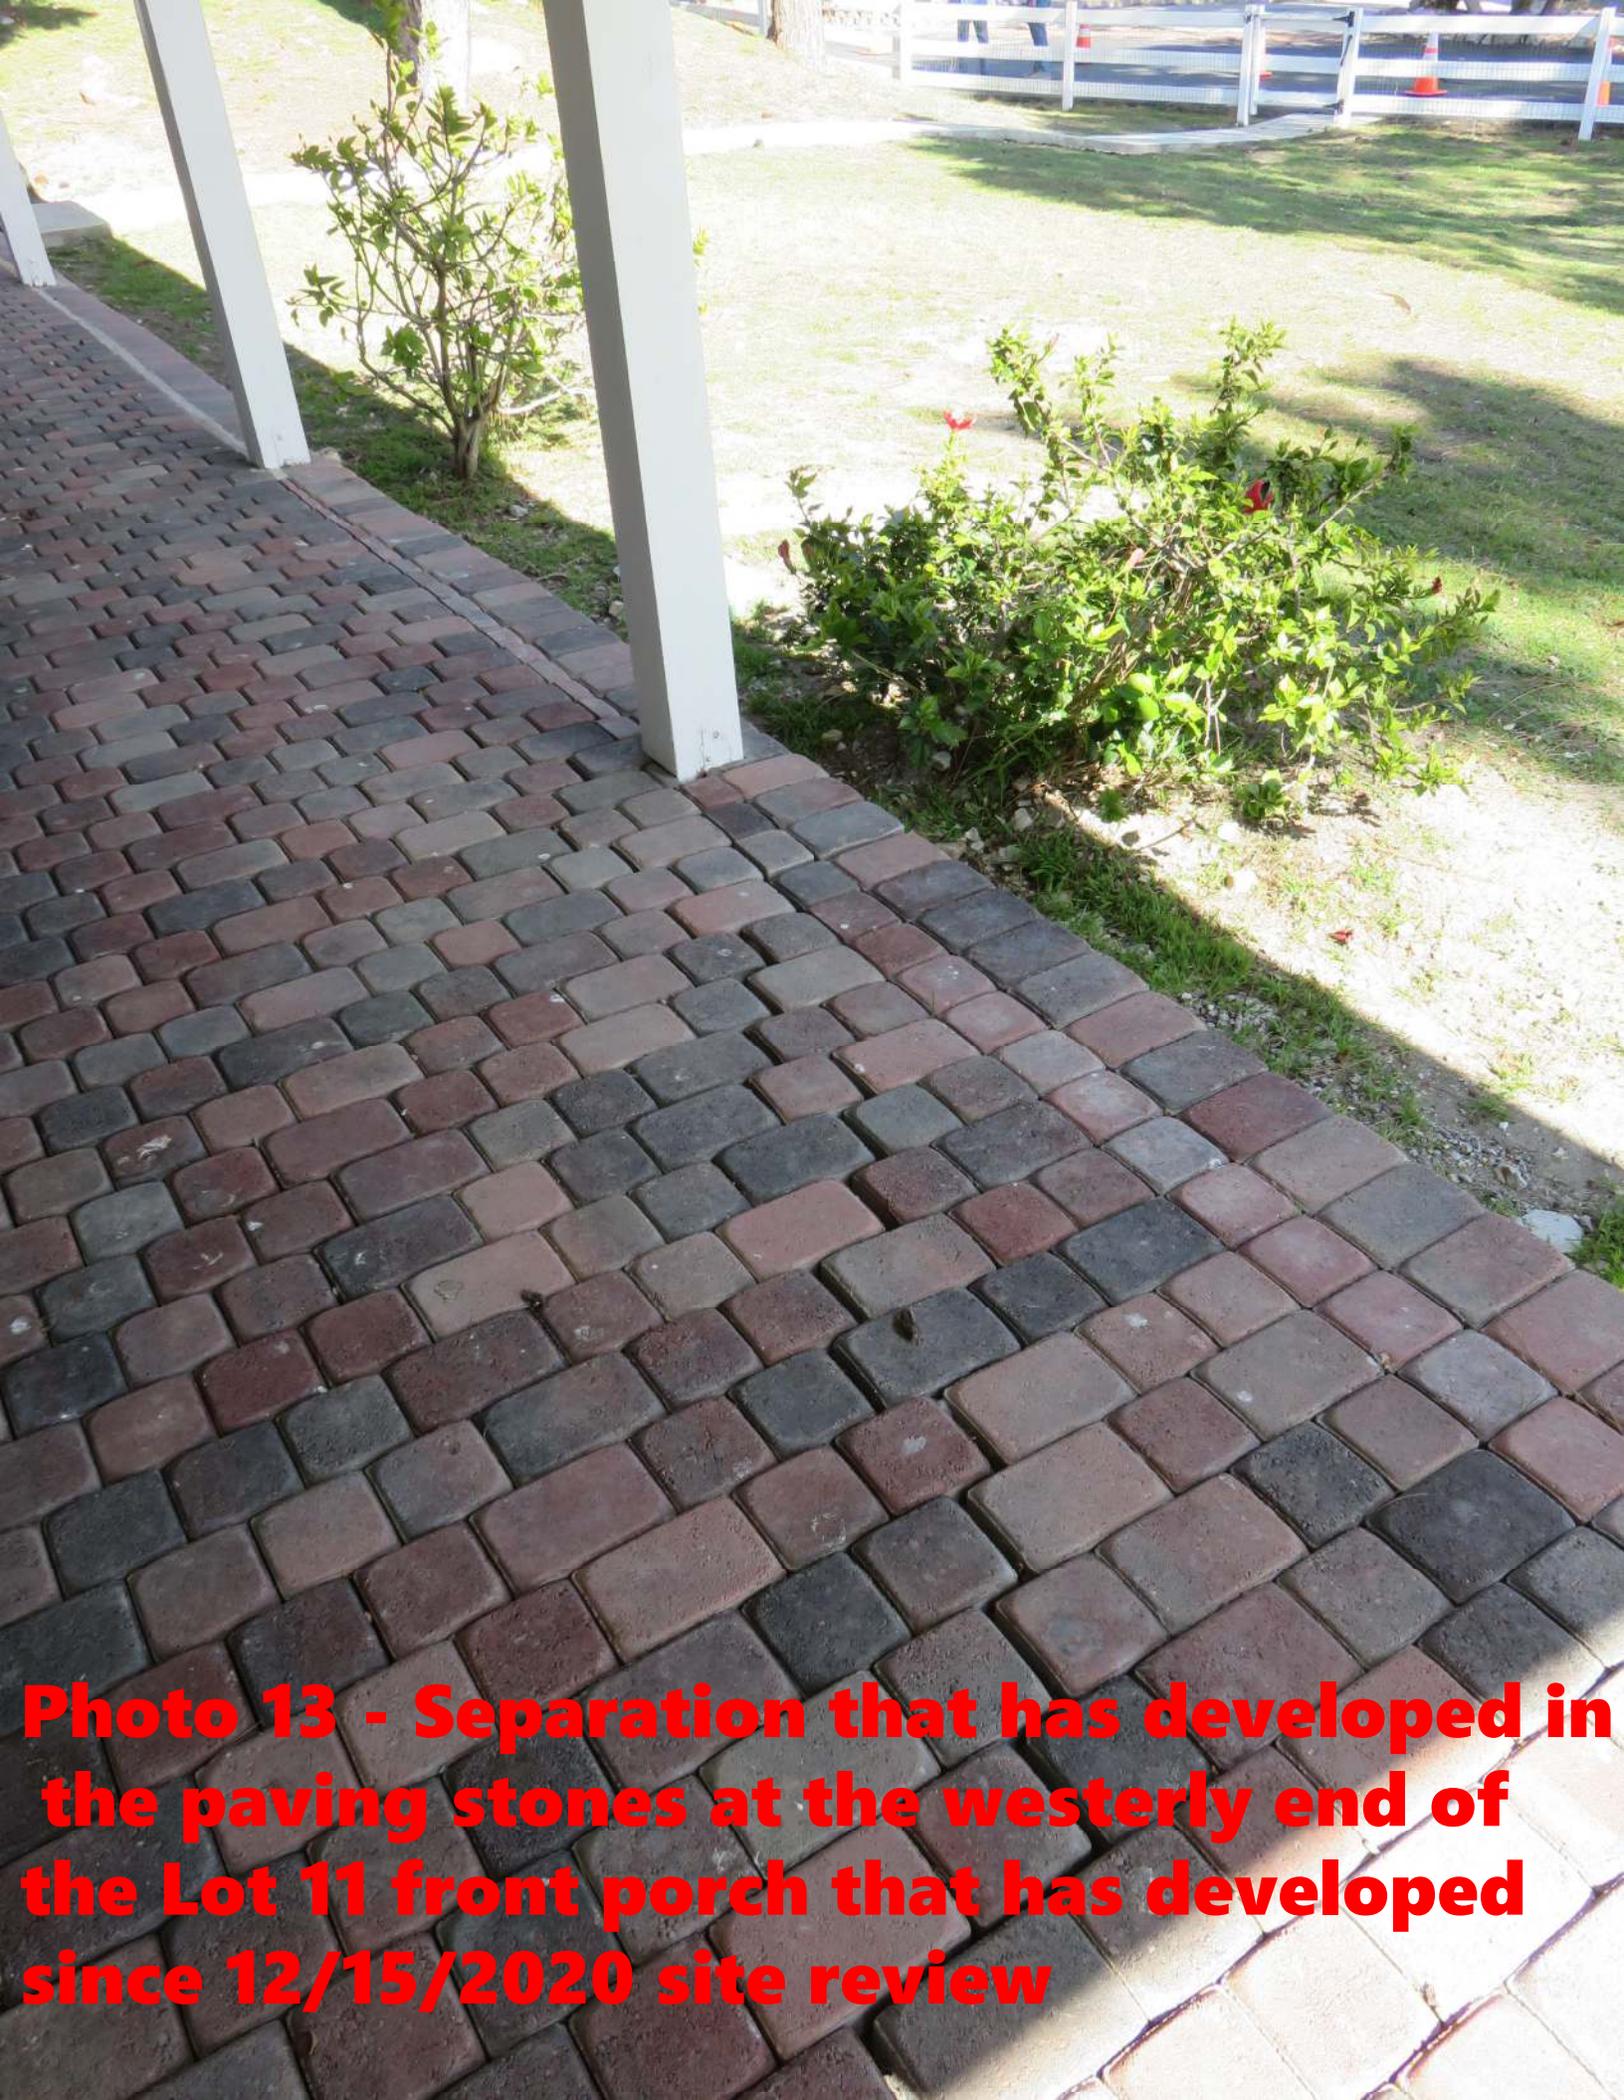
Photo 13 - Separation that has developed in the paving stones at the westerly end of the Lot 11 front porch that has developed since 12/15/2020 site review

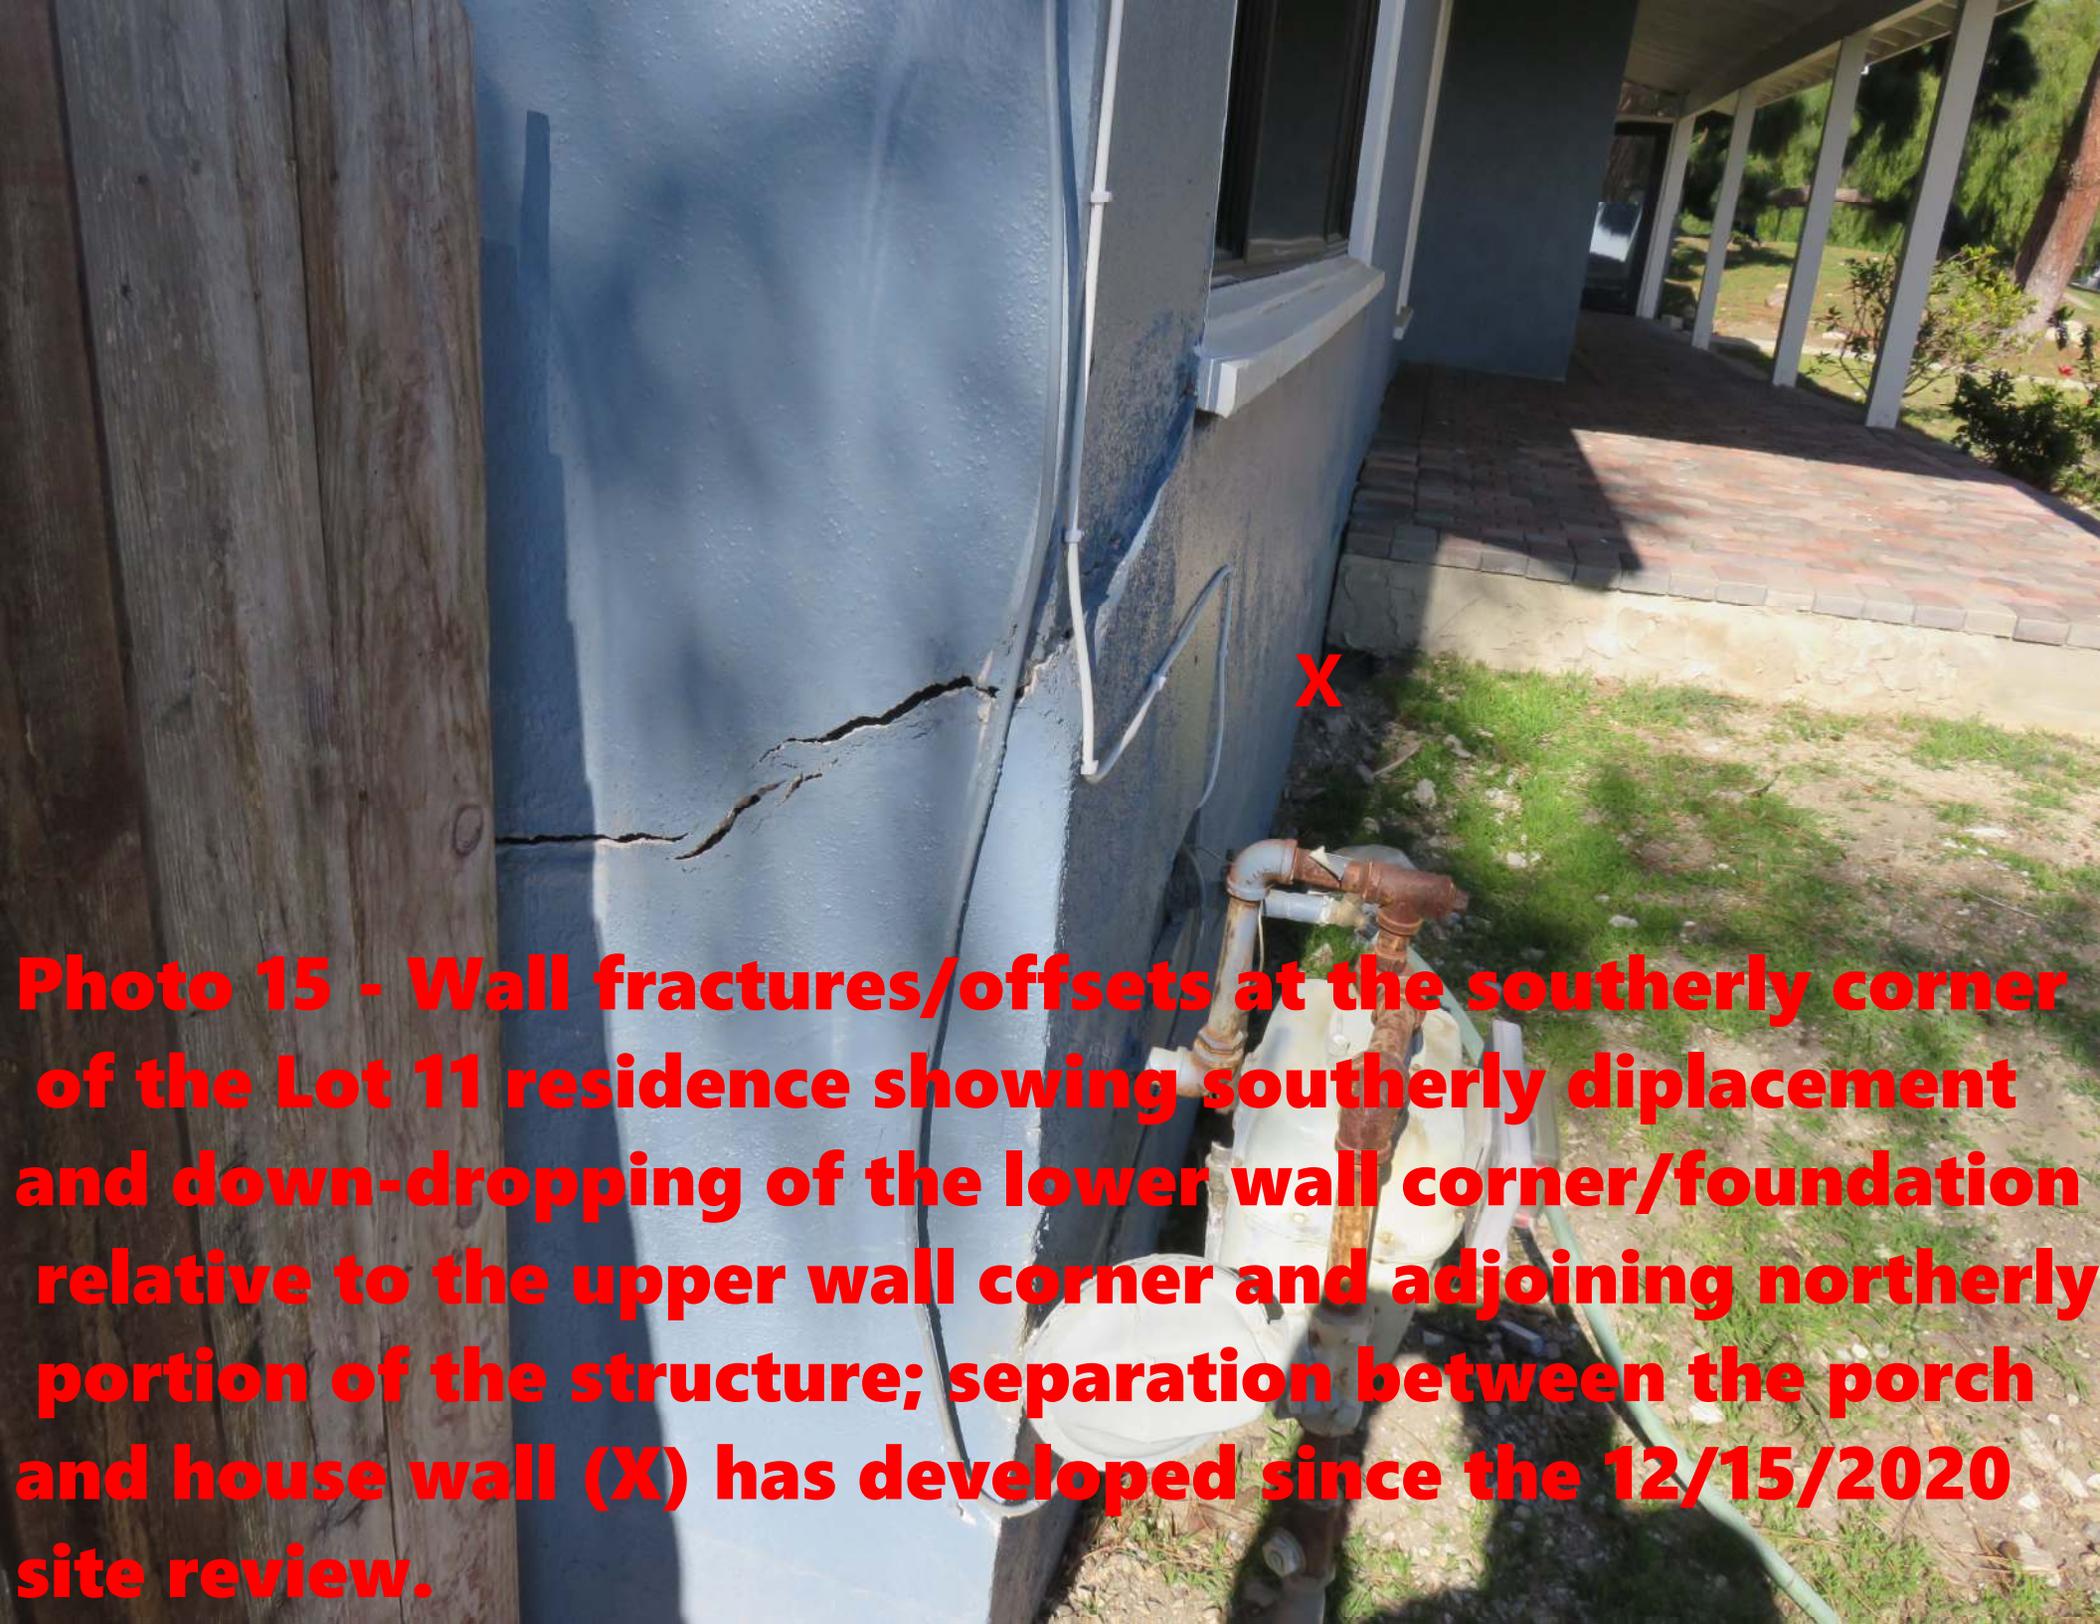
However, a noticeable separation is now present between the westerly end of the front porch and the adjoining stucco wall of the residence (Photo 15).

The gas meter for the Lot 11 residence is located adjacent to the damaged wall corner, along the projected trend of the observed ground deformation zone. Apparent tilting of the meter and associated plumbing suggests it may have been displaced to some extent by the ground movement (Photos 14 and 15). In response to inquiries after the site visit, the homeowner reported that the Southern California Gas Company has been onsite and checked the conditions.

Photo 15 - Wall fractures/offsets at the southerly corner of the Lot 11 residence showing southerly displacement and down-dropping of the lower wall corner/foundation relative to the upper wall corner and adjoining northerly portion of the structure; separation between the porch and house wall (X) has developed since the 12/15/2020 site review.

The gas meter for the Lot 11 residence is located along the projected trend of observed ground deformation zone, immediately adjacent to the damaged/displaced southerly corner of the house. Apparent tilting of the meter and associated plumbing suggests it may have been displaced to some extent by the ground movement. Although representatives of the Southern California Gas Company have reportedly been onsite and checked the conditions, some consideration should be given to replacing all the pipe fittings in the immediate vicinity of the meter to remove any stress that may have accumulated from the ground deformation. The portion of the plumbing that extends through the wall into the crawl space below the house is of greatest concern because of the potentially catastrophic consequence of a leak and accumulation of gas in the crawl space area.
