4/15/2021

Abalone Cove Landslide Abatement District
P.O. Box 3675
Palos Verdes Peninsula, CA 90274.
Attention: Tim Kelly and Michael Barth

**Second Site Meeting and Review Re: Ground Deformation/Local Damage
Near Intersection of Cinnamon Lane and Clove Tree Place
Abalone Cove Residential Area, Rancho Palos Verdes, California**

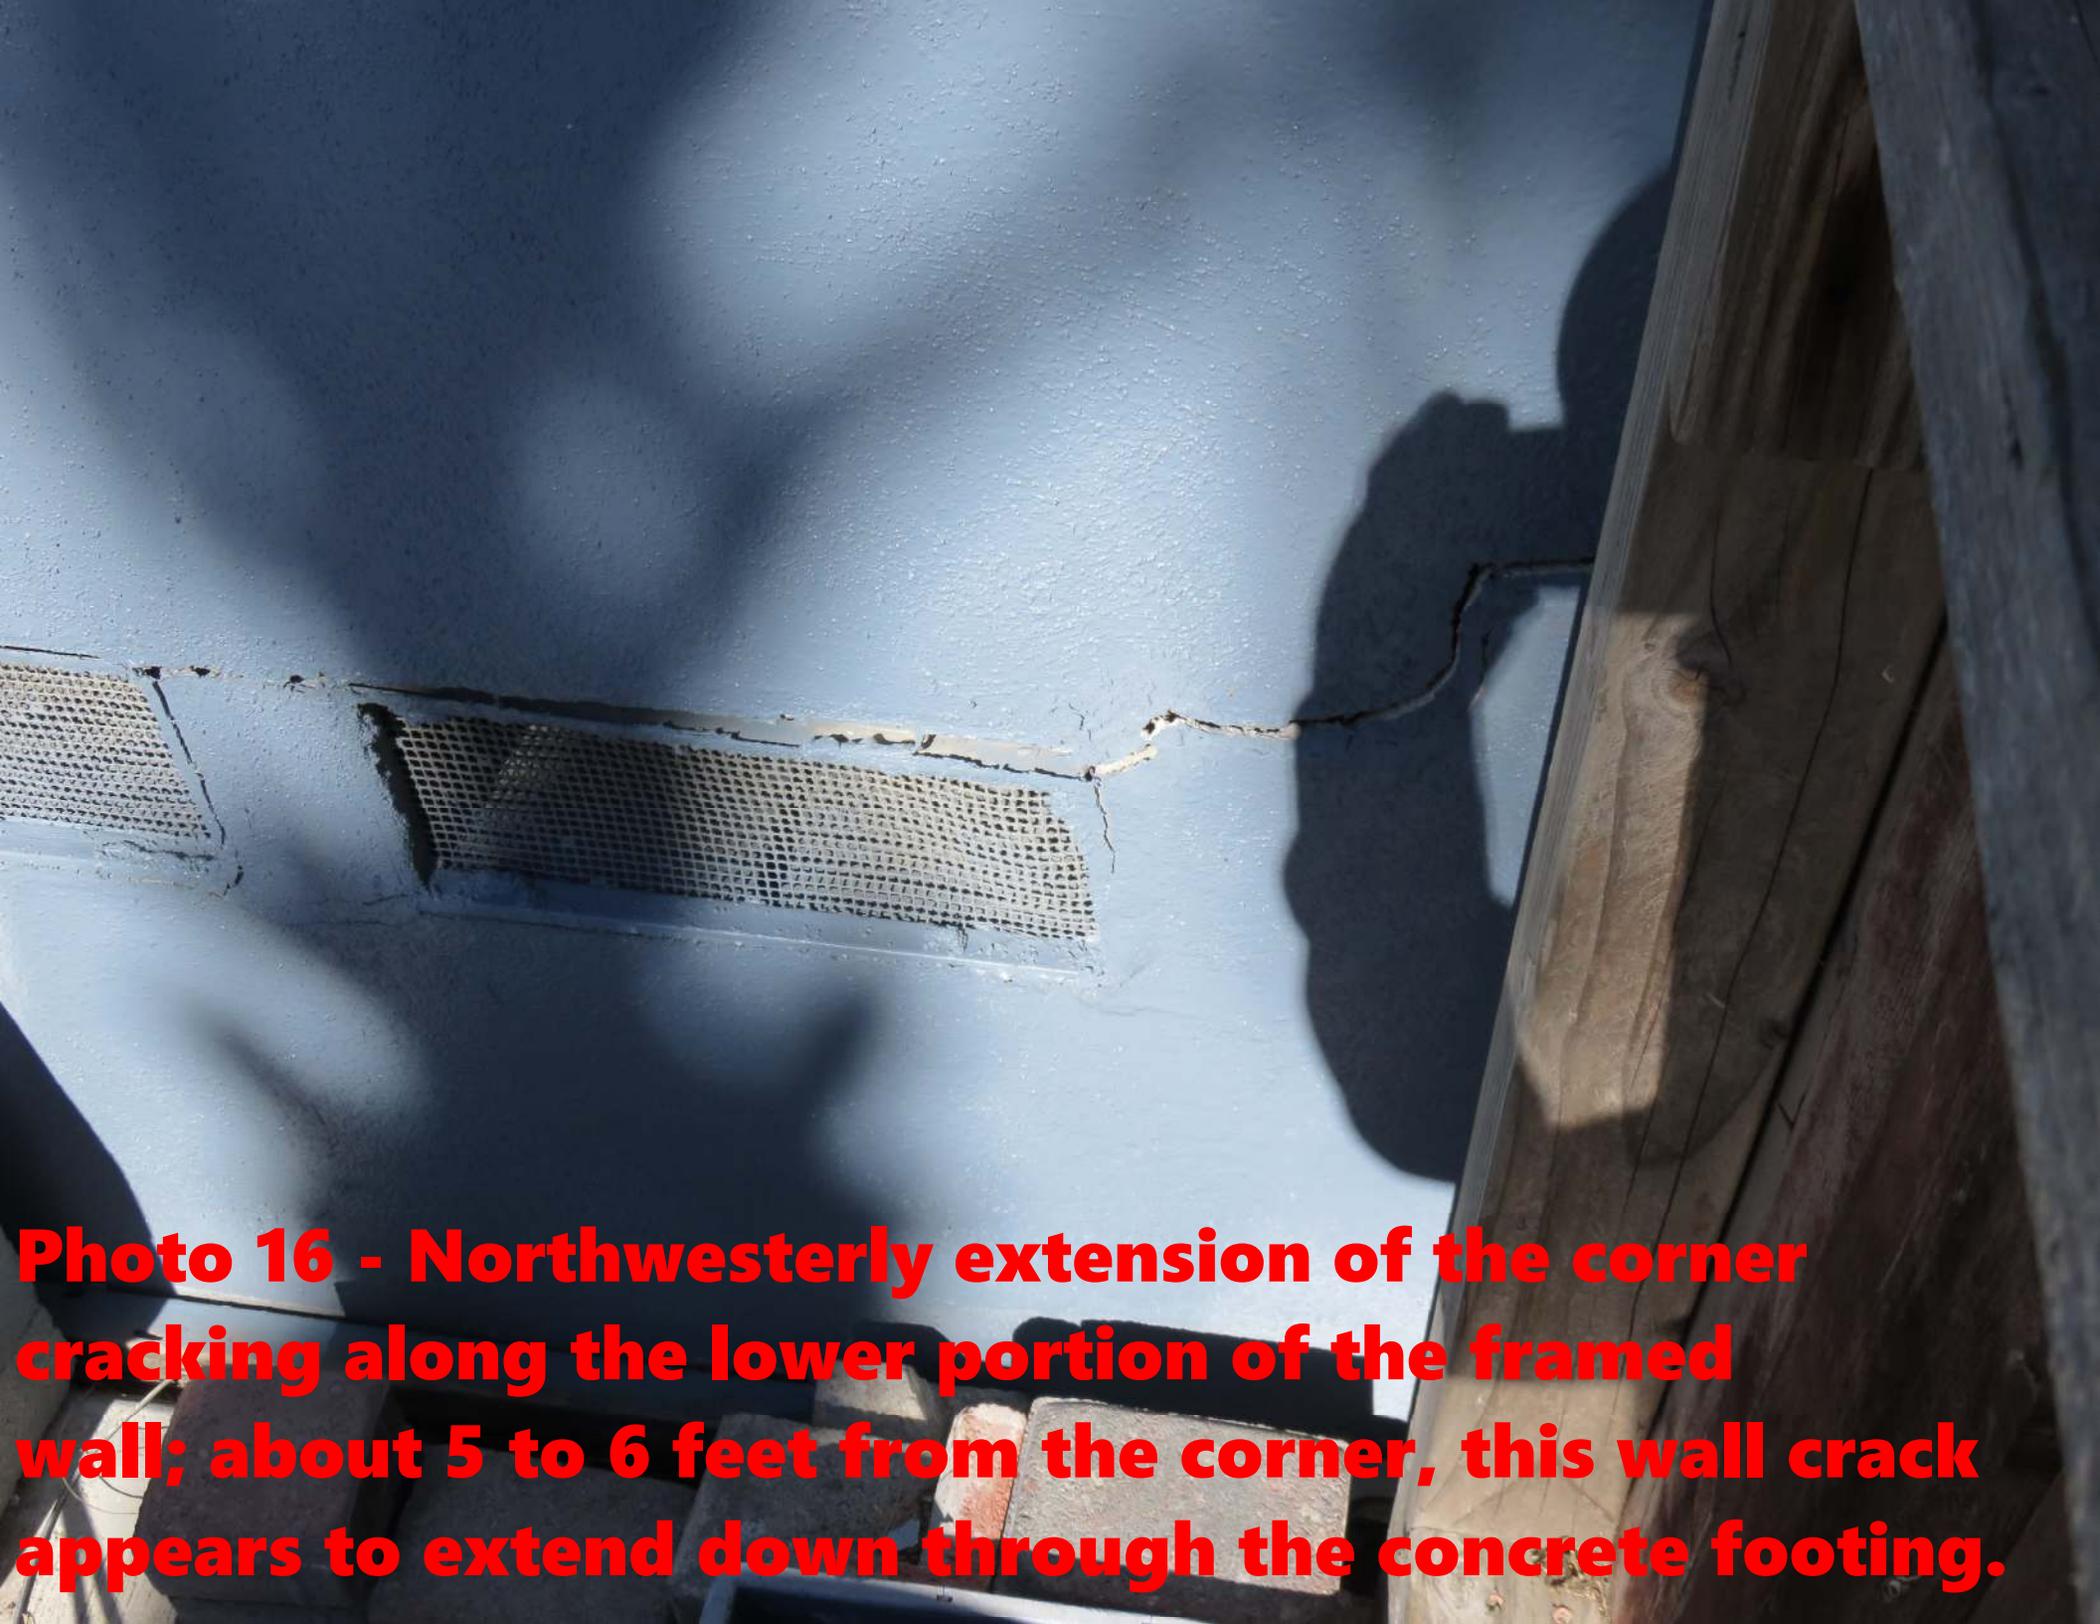
Photo 16 - Northwestern extension of the corner cracking along the lower portion of the framed wall; about 5 to 6 feet from the corner, this wall crack appears to extend down through the concrete footing.

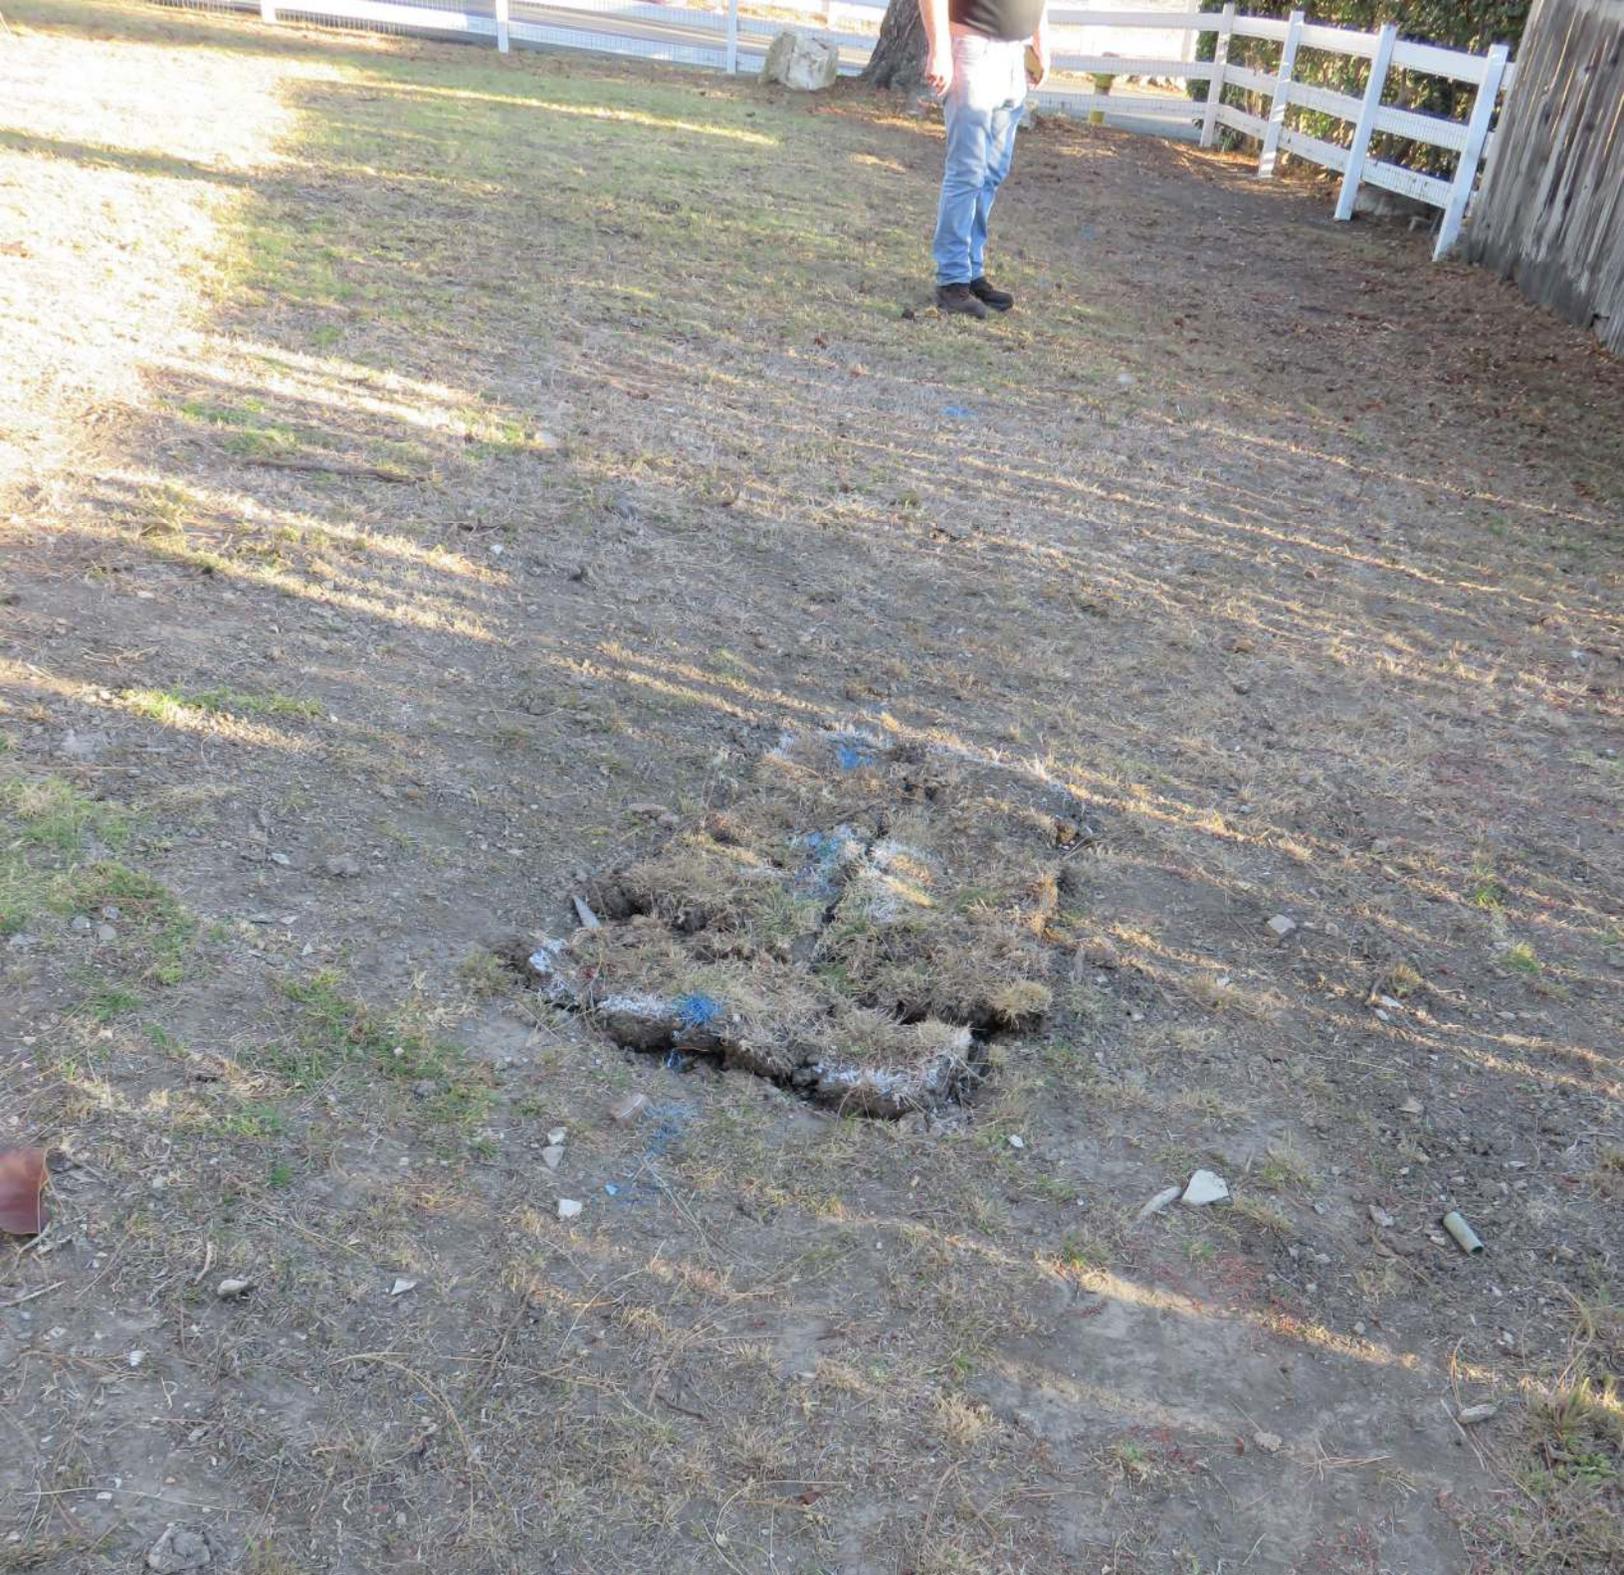
A westerly projection of the southerly set of tension cracks across the yard from Clovetree Place coincides with the previously identified irrigation line repair (refer to attached site plan distress plot and Photo 17).

Photo 17 - Irrigation line break/leak repair on Lot 11, located about 15 feet southerly of the damaged wall corner, along the projected west trend of the southerly tension cracking zone (refer to site plan).

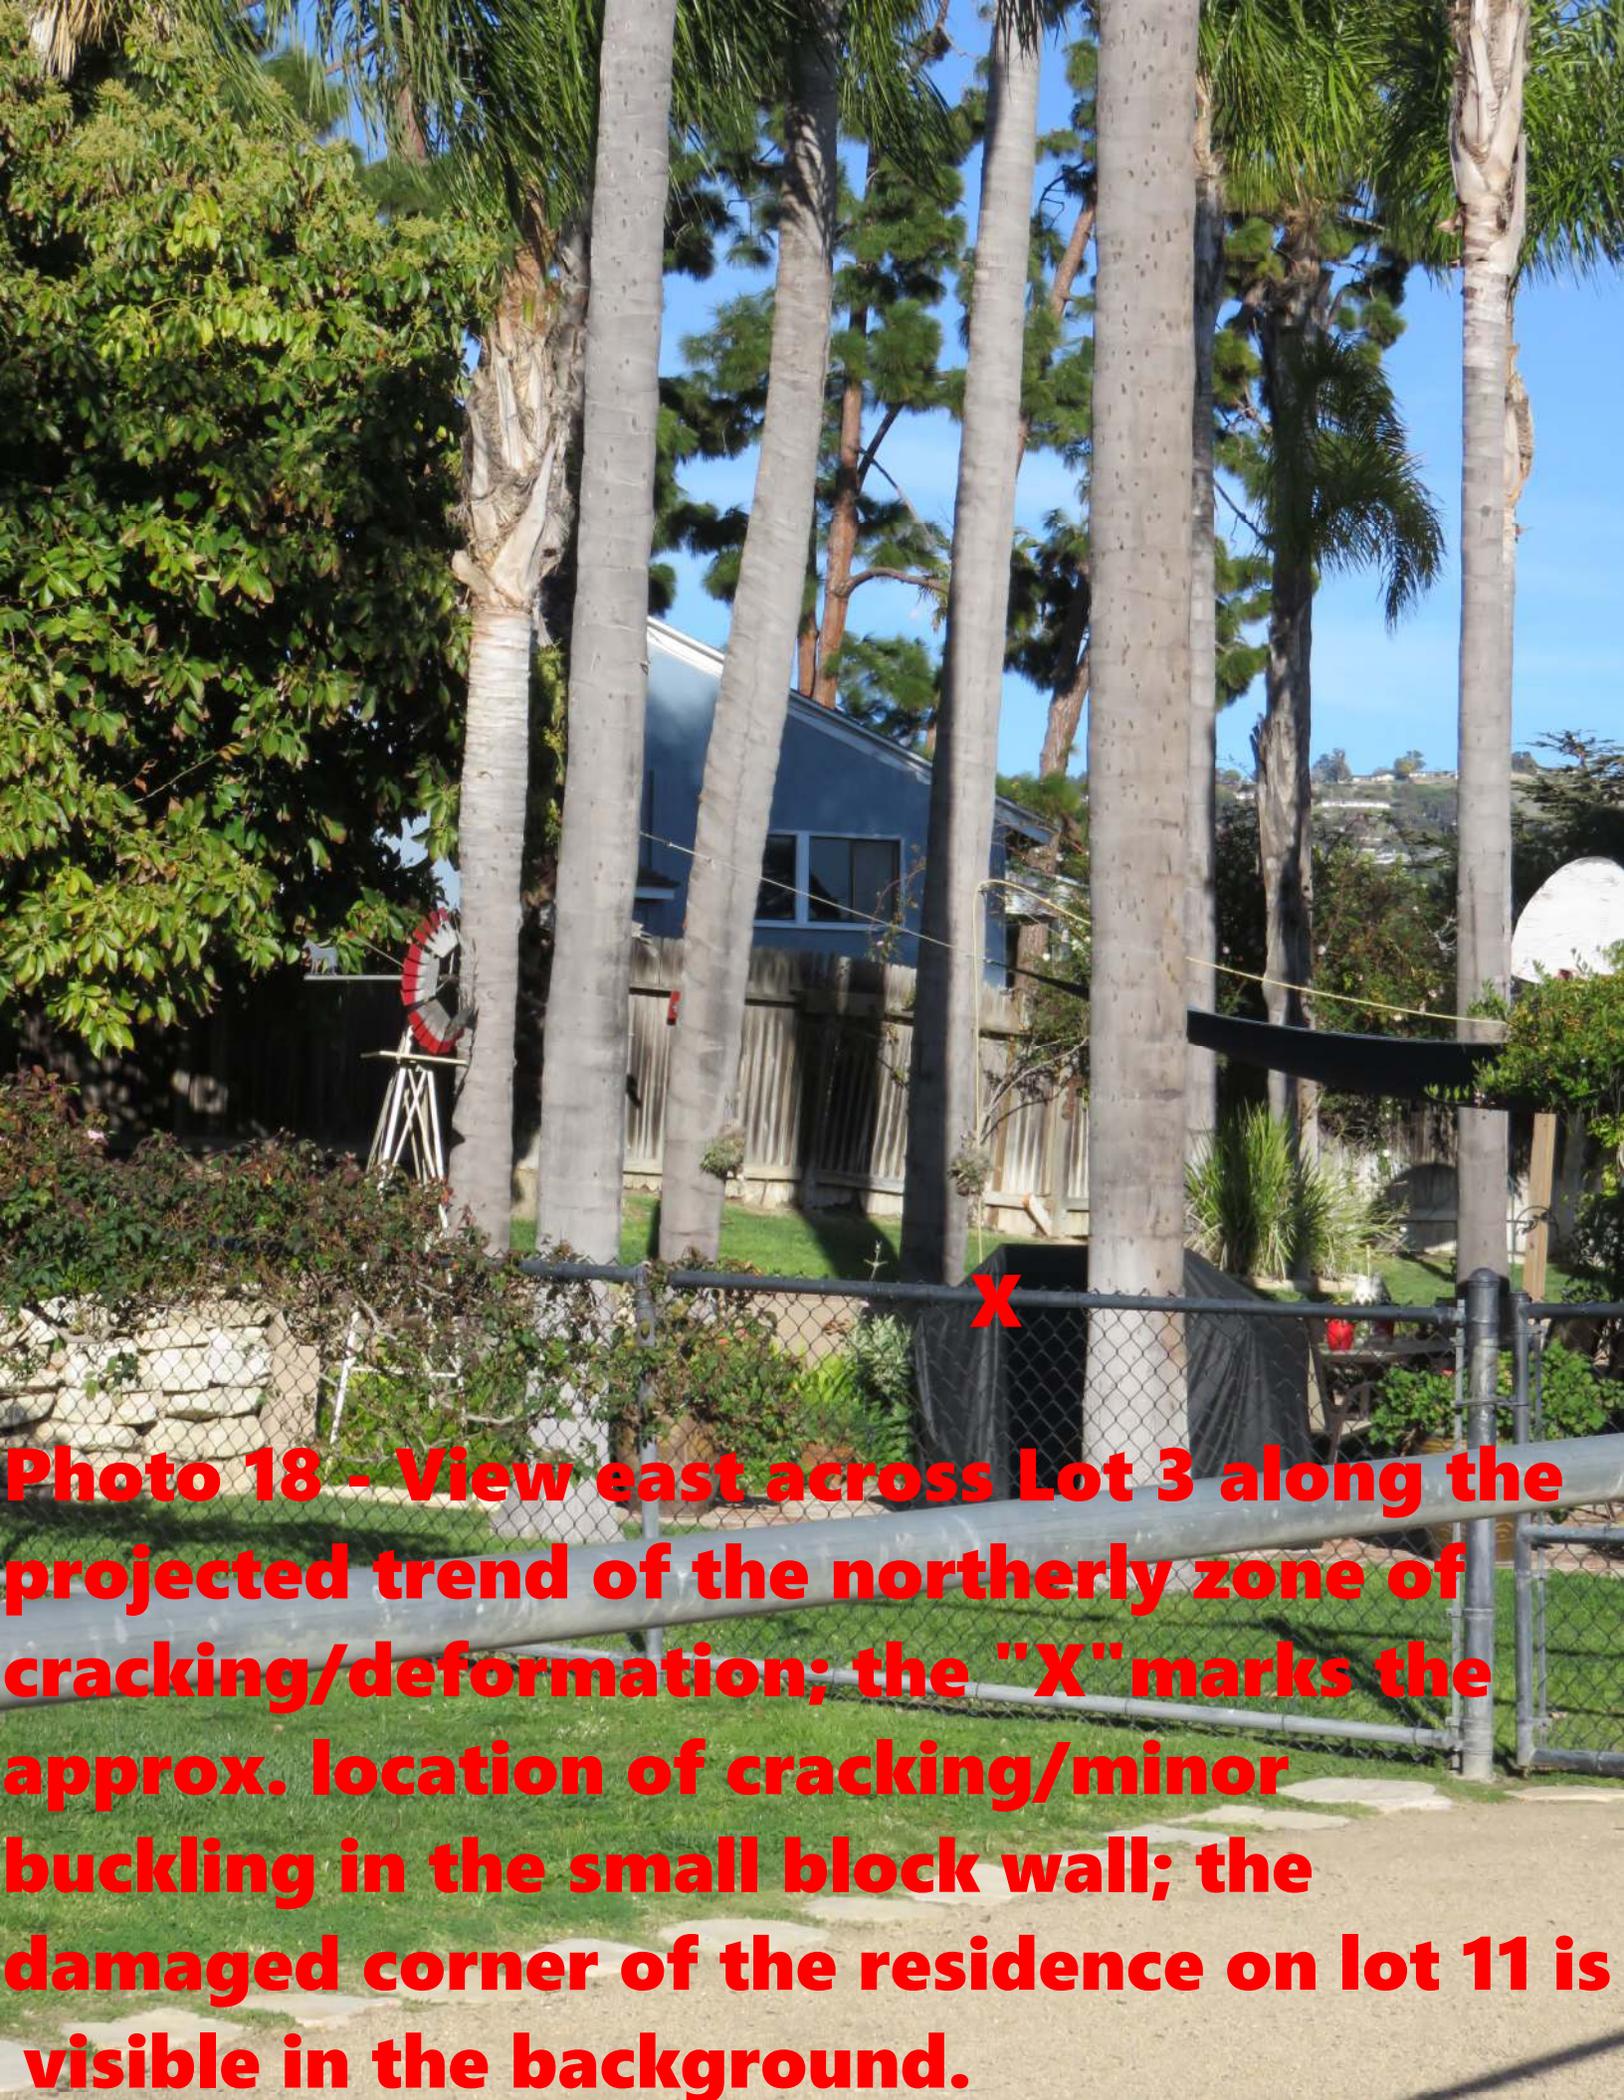
No attempt was made to access Lot 3 on the southwesterly side of Lot 11 during the December 15, 2020 site review. However, during the course of the March 19, 2021 site review, discussions with the Lot 3 homeowner, Mr. Gutierrez, indicated that there are some fractures and slight buckling of a small, concrete block, garden wall on the easterly side of his yard, along the trend of the nearby distress features on Lot 11 (refer to site plan distress plot). Although a quick glimpse of these cracks was made, the sudden appearance of the family dog in that part of the yard did not allow any close-up photographs to be taken. Mr. Gutierrez indicated that there did not appear to have been any recent changes in the wall cracks. A photograph along the east-west trend of the garden wall and stucco house wall cracking on Lots 3 and 11 was taken from the westerly side of the yard (Photo 18).

Photo 18 - View east across Lot 3 along the projected trend of the northerly zone of cracking/deformation; the "X" marks the approx. location of cracking/minor buckling in the small block wall; the damaged corner of the residence on lot 11 is visible in the background.

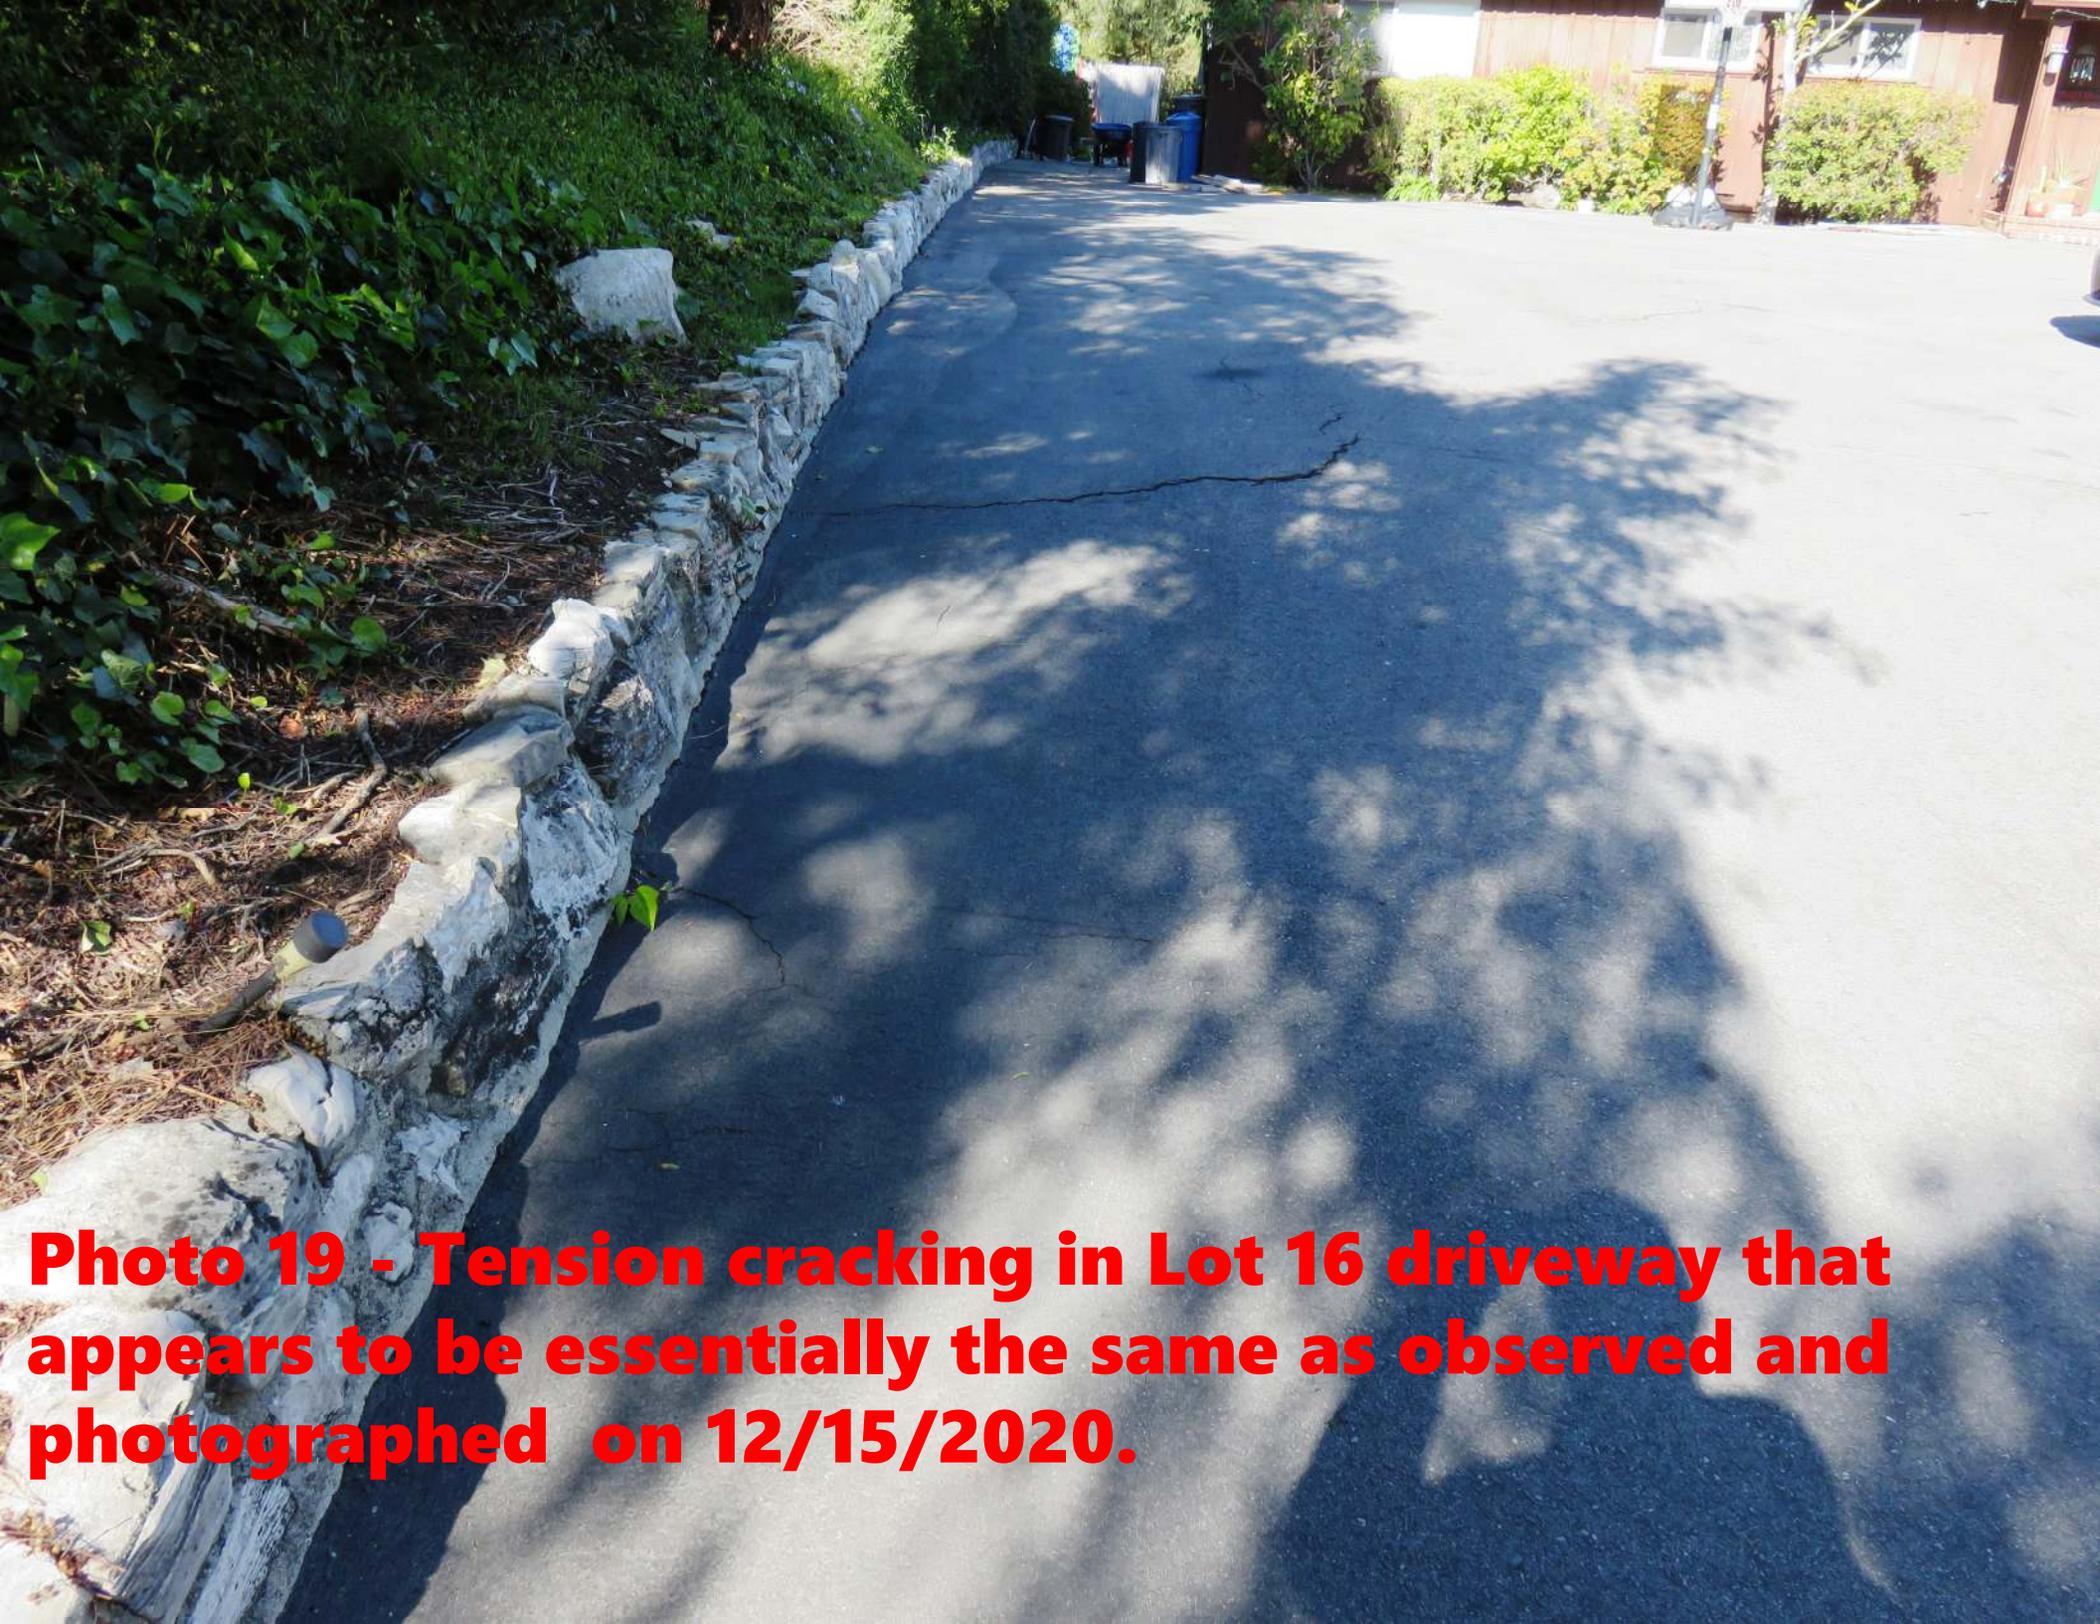
Similar to the previous site review, observations on Lot 16 were limited to views/photographs of the tension cracks in the asphalt driveway from the street right-of-way. No significant changes in the length or width of these cracks appeared to have occurred (refer to site plan distress plot and Photo 19).

Photo 19 - Tension cracking in Lot 16 driveway that appears to be essentially the same as observed and photographed on 12/15/2020.
