Engineer's Report

KLONDIKE CANYON GEOLOGIC HAZARD ABATEMENT DISTRICT

FISCAL YEAR 2023-24

Project: 2023-24 Abatement Activities Within the District

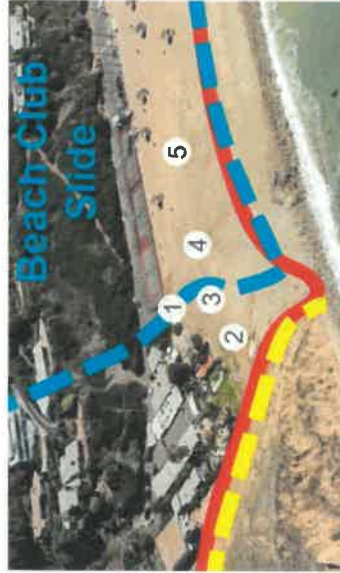
Step 2

5 active Wells ~ 400K Gal/day
210 days to remove 2023 rains (have 2-wells now)

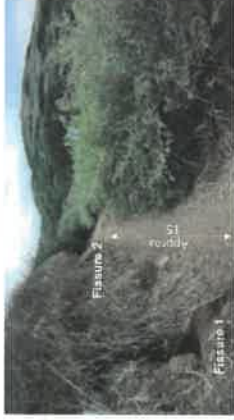
Step 3

Fill Fissures Head of Klondike Slide

Remove earth to relieve pressure in PBC
